Willington Municipal Facilities Study

WILLINGTON, CT
DECEMBER 3, 2013

In 2009, Kaestle Boos Associates reviewed existing conditions of the following facilities:

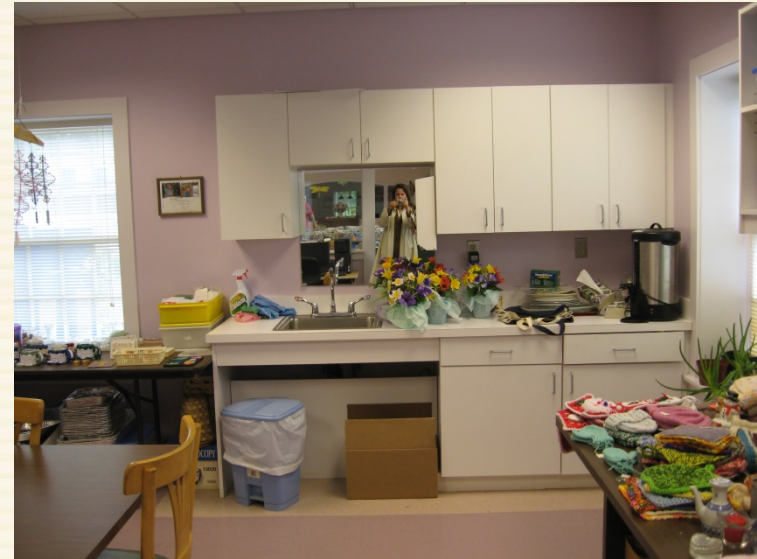
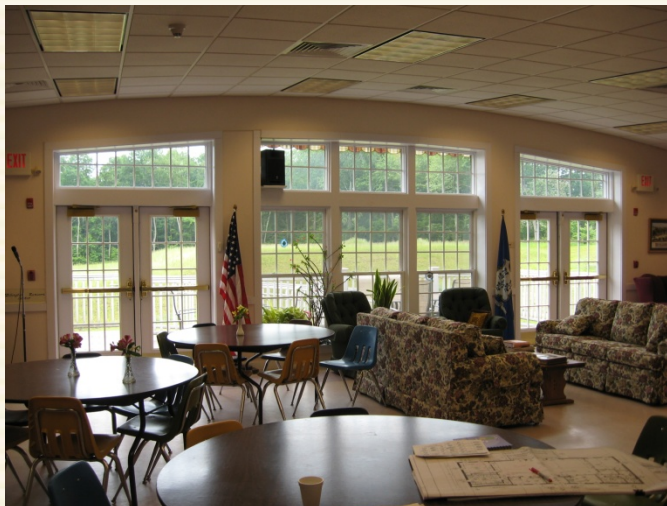
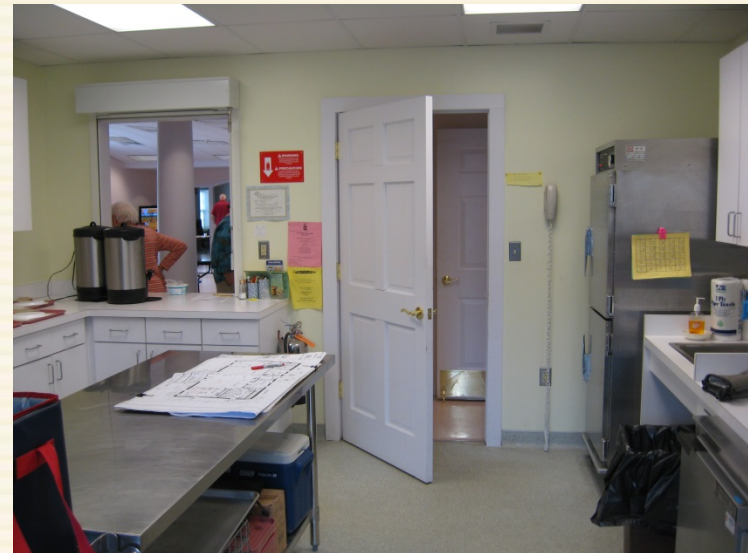
- ❖ Repair fitting at kitchen sink and provide grease interceptor
- ❖ Handicapped accessibility lacking at sinks and cabinets
- ❖ Seating is limited for large functions
- ❖ Storage is limited

- Provide automatic sprinkler protection for the entire facility
- Repair fitting at kitchen sink and provide grease interceptor
- Alter sinks and cabinets to provide handicapped accessibility
- Expand Great Room for additional seating
- Expand and alter restrooms, replace fixtures to conserve water
- Expand Kitchen
- Provide additional storage space at lower level
- Upgrade air handling units to increase efficiency
- Provide additional Parking
- Upgrade septic system
- Restripe handicapped parking spaces and install bollards

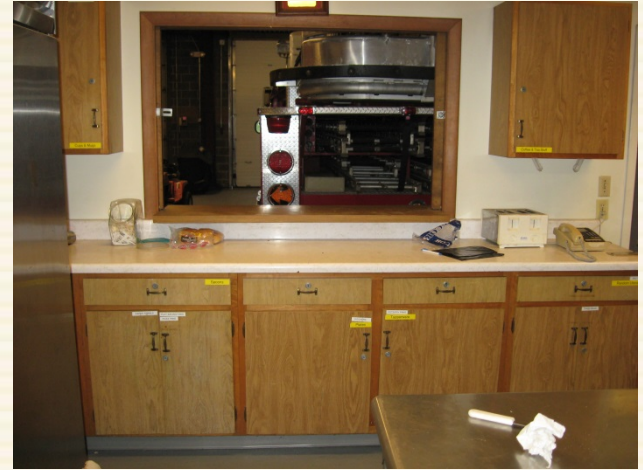
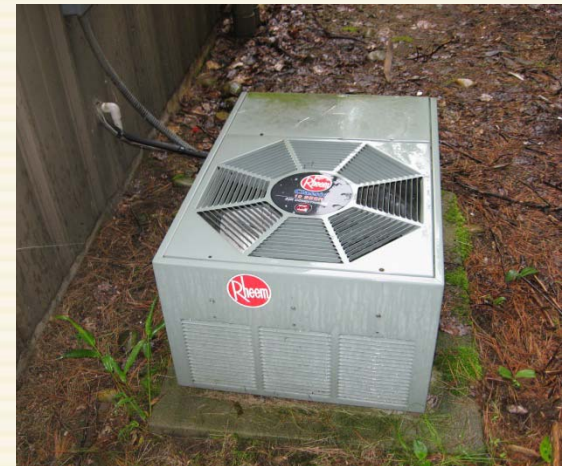
- ❖ Kitchen lacks exhaust hood, make up air, and fire suppression system
- ❖ Kitchen lacks grease interceptor
- ❖ Plumbing fixtures are not water-conserving type
- ❖ Pipe insulation is lacking
- ❖ Backflow preventers and air gap fittings are missing
- ❖ Finned-tube radiation is in poor condition
- ❖ Exhaust fans are in poor condition
- ❖ Air conditioning is in poor condition
- ❖ Electrical service is in poor condition

- Construct an addition to meet programmatic needs
- Provide exhaust hood, make up air, and fire suppression system for kitchen
- Provide grease interceptor
- Alter toilet rooms to be accessible and provide water-conserving fixtures
- Provide backflow preventers and air gap fittings
- Replace air-conditioning equipment and finned-tube radiation
- Replace exhaust systems
- Replace electrical system
- Replace internal communication panel
- Provide new fire alarm system
- Upgrade lighting
- Replace emergency lighting and exit signs
- Replace doors and windows
- Alter doors, toilet rooms, counters, locker rooms, and parking to provide handicapped accessibility
- Provide room identification signage

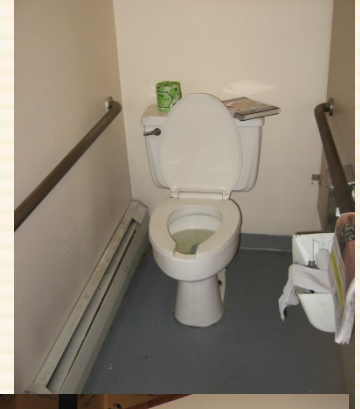
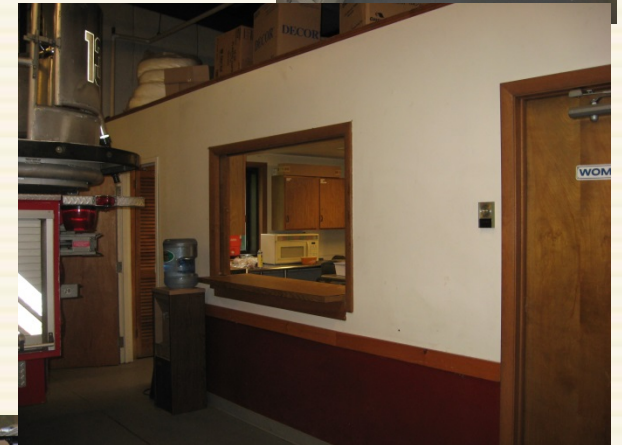
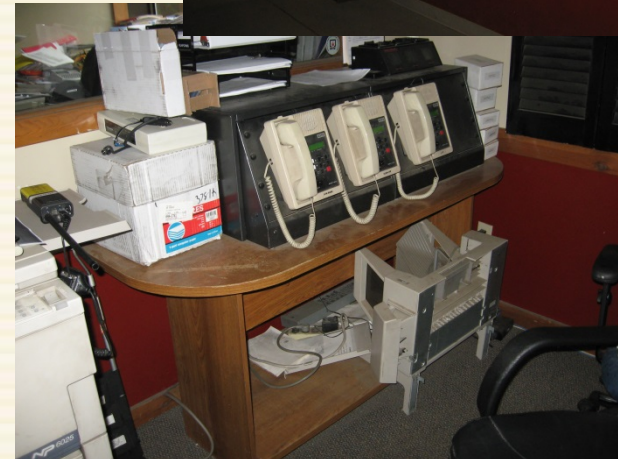
- ❖ Internal communication panel is in poor condition
- ❖ Lighting, emergency lighting, and exit signs are in poor condition
- ❖ Doors and windows are not energy efficient
- ❖ Handicapped accessibility is lacking at doors, plumbing fixtures, counters, locker rooms, signage, and parking spaces
- ❖ Additional space is needed for apparatus bays, day room, lockers, bunks, training, and support spaces

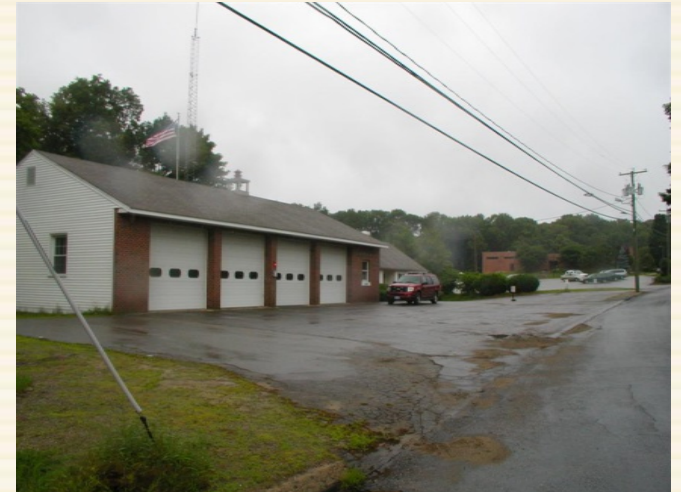
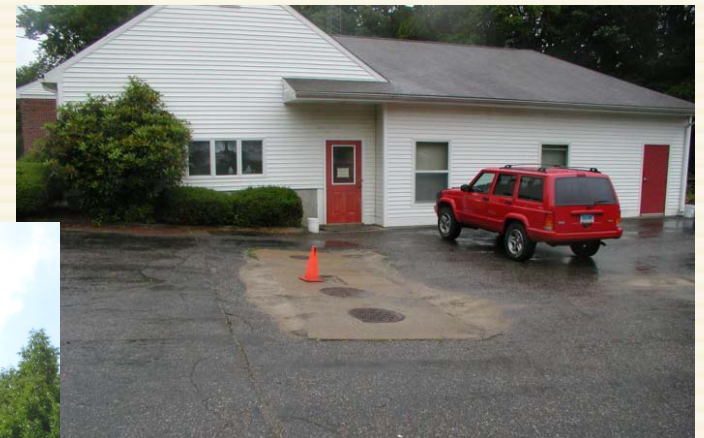
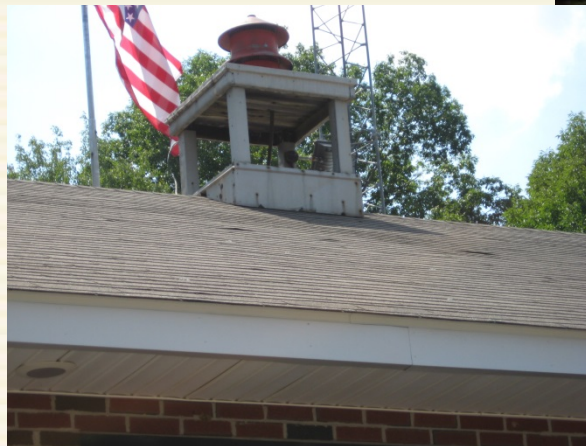
- ❖ Parking spaces are not defined
- ❖ Pavement is in disrepair
- ❖ Outdoor storage is needed
- ❖ Roof has exceeded life expectancy
- ❖ Additional space is needed for apparatus bays, offices, day room, lockers, bunks, exercise, and support spaces
- ❖ Site constraints limit expansion

- Upgrade emergency lighting, exit signs, and fire alarm
- Provide exhaust systems
- Provide make up air for kitchen
- Alter stair railings
- Provide grease interceptor and oil separator
- Upgrade plumbing fixtures and provide kitchen hand sink
- Provide automatic sprinkler protection for the entire facility
- Alter doors, plumbing fixture arrangement, and counters to provide handicapped accessibility
- Provide inclined wheelchair lift for accessibility
- Provide room signage
- Delineate parking spaces and repair/replace paved surfaces
- Provide outdoor storage
- Replace roof
- Provide new air-conditioning units
- Replace electrical service

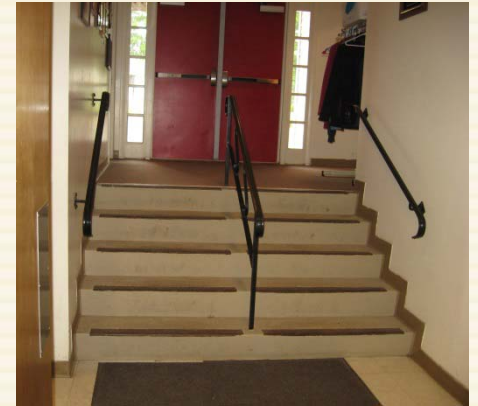
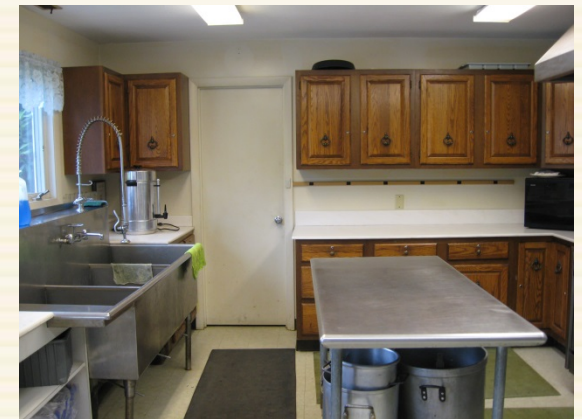
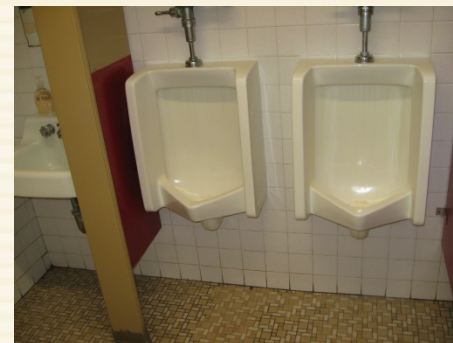
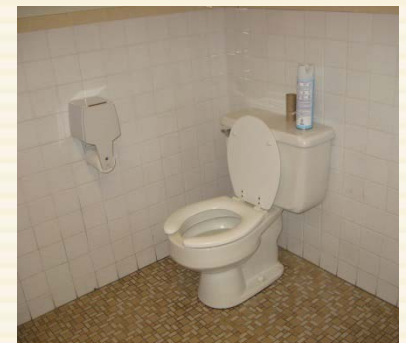
- ❖ Electrical service, panels and generator are in poor condition
- ❖ Fire alarm system lacks monitoring
- ❖ Apparatus bays lack heat detectors and fire alarm pull stations
- ❖ Emergency lighting and exit signs are in poor condition
- ❖ Building lacks exhaust systems
- ❖ Kitchen lacks required make up air
- ❖ Kitchen lacks grease interceptor
- ❖ Apparatus bays lack oil separator
- ❖ Handicapped accessibility is limited
