Foundation Assessment Willington Public Library

7 Ruby Road (Route 320)
Willington CT

prepared for
Town of Willington CT

Project 19-163

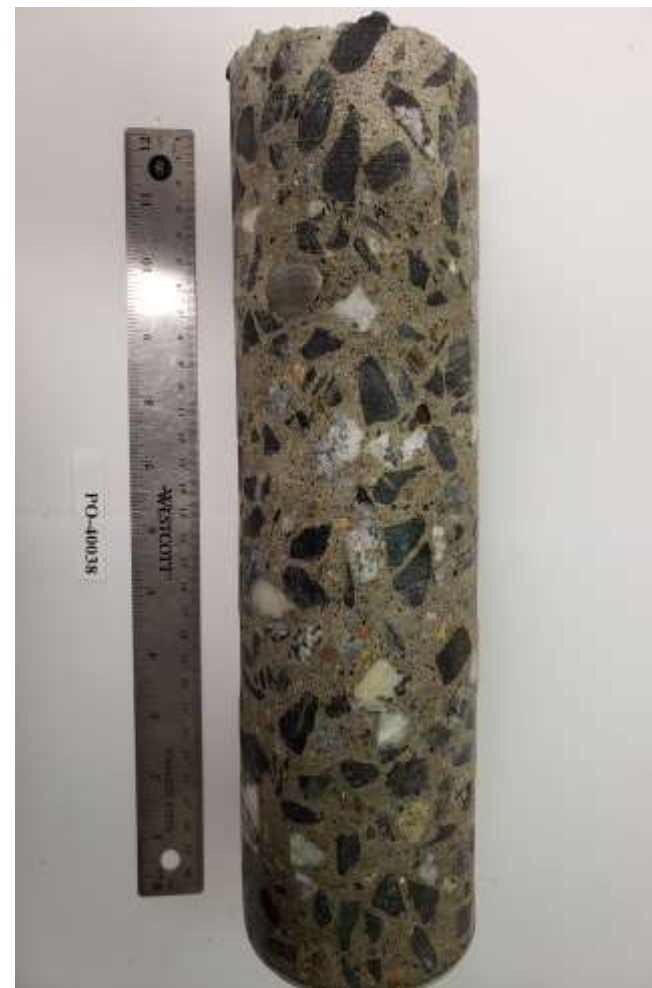
| Sampled by : | Structures Consulting | Core ID : | 1-BW-MB-EXT |

Exterior moisture barrier: - mm
Parging cement : - mm
Original concrete:: 283 mm
Cementitious coating: 2 mm
Total length: (11.221") 285 mm

Visible iron sulfides: Clusters
Magnetism : Weak to moderate
Oxidation/alteration: Trace

General condition : Good
Spalling : none
Delaminating : none
Cracking: none
Aggregate/paste bond: Good

Diameter: 1/2"
Corrosion: none
Orientation: 90° to core direction
Steel/paste contact: Good

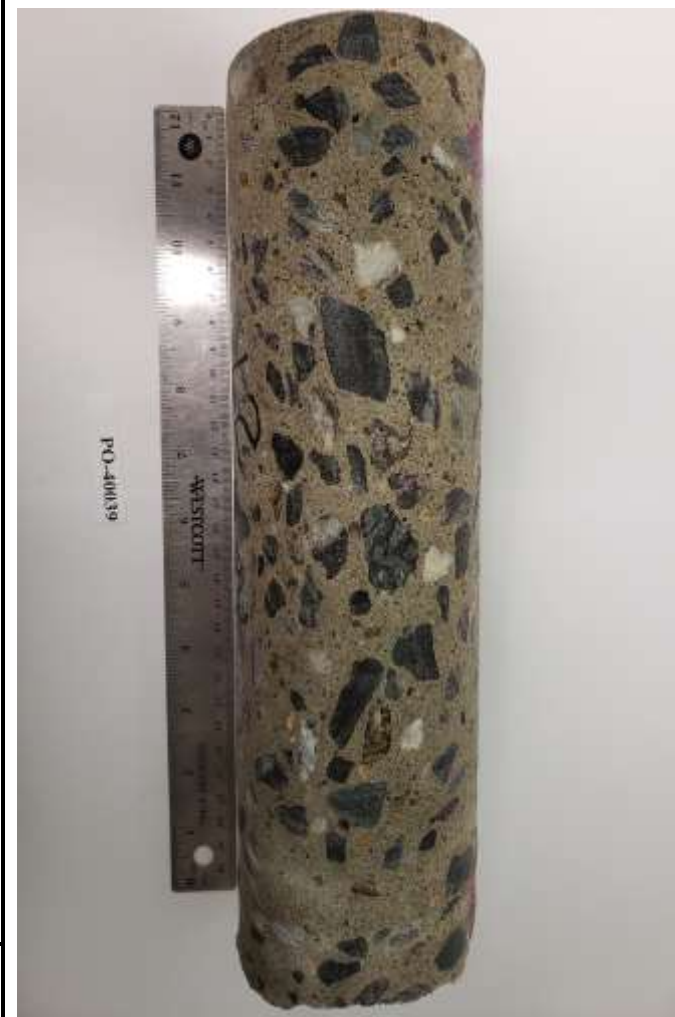
Interior moisture barrier: - mm
 Paint : - mm
 Original concrete:: 290 mm
 Exterior moisture barrier: - mm
 Total length: (11.417") 290 mm

General condition : Good
 Spalling : none
 Delaminating : none
 Cracking: none
 Aggregate/paste bond: Good

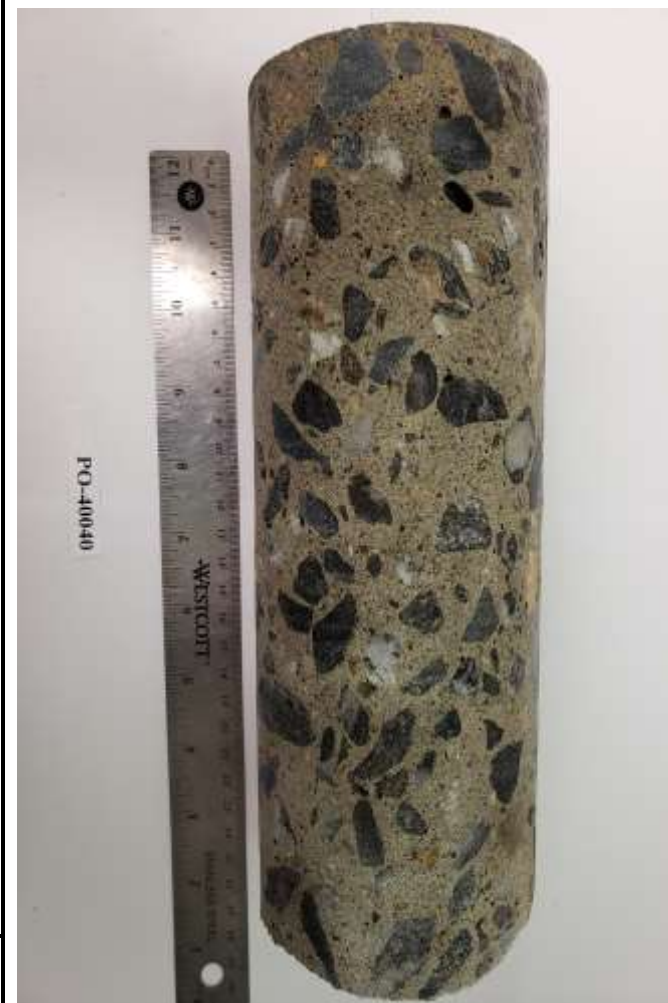
Interior moisture barrier: - mm
 Paint : - mm
 Original concrete (fractured): 230 mm
 Exterior moisture barrier: - mm
 Total length: (9.055") 230 mm

General condition : Good
 Spalling : none
 Delaminating : none
 Cracking: none
 Aggregate/paste bond: Good

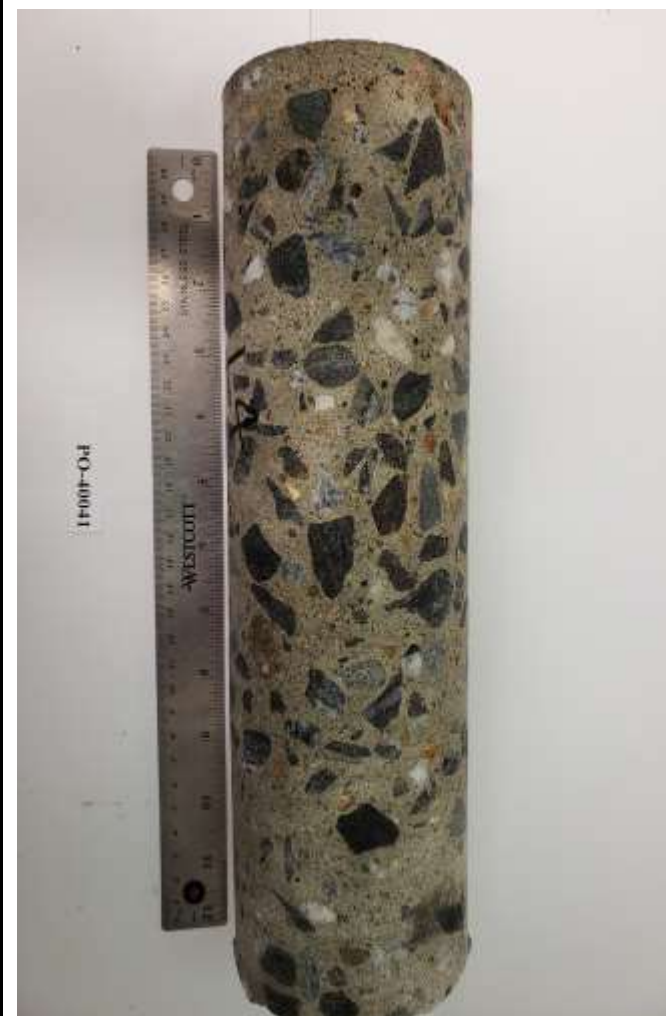
Interior moisture barrier: - mm
 Paint : - mm
 Original concrete (fractured): 290 mm
 Exterior moisture barrier: - mm
 Total length: (11.417") 290 mm

General condition : Good
 Spalling : none
 Delaminating : none
 Cracking: none
 Aggregate/paste bond: Good

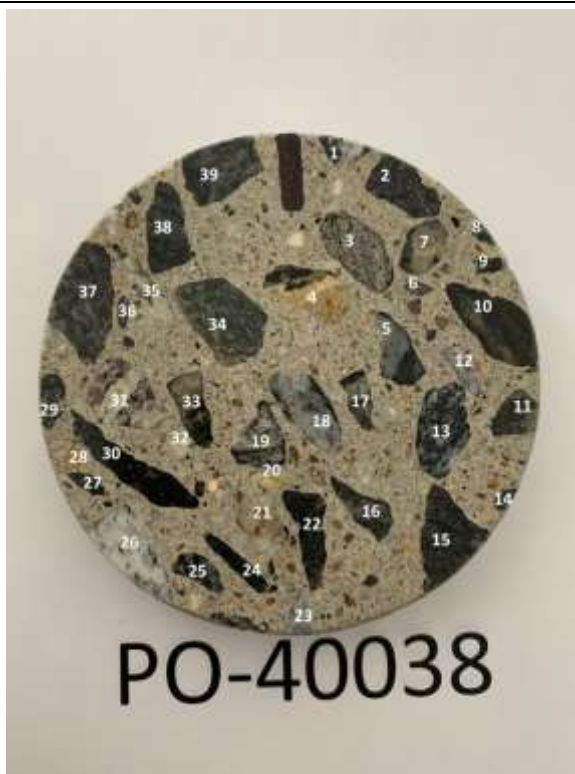
PO-40038

| Sulfide oxidation : | Moderate amounts of pyrrhotite oxidation and replacement iron oxides were observed in 16% of pyrrhotite-bearing coarse aggregates (13 of 80 particles), with no associated significant cracking distress. |

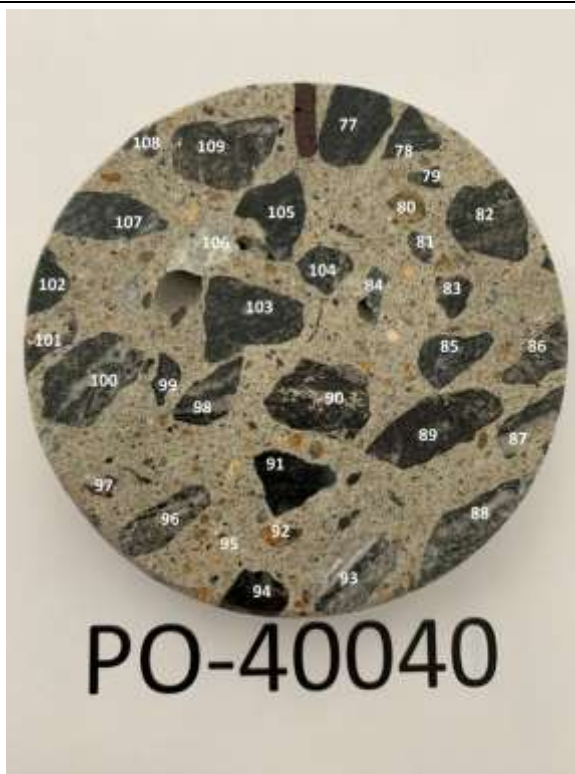
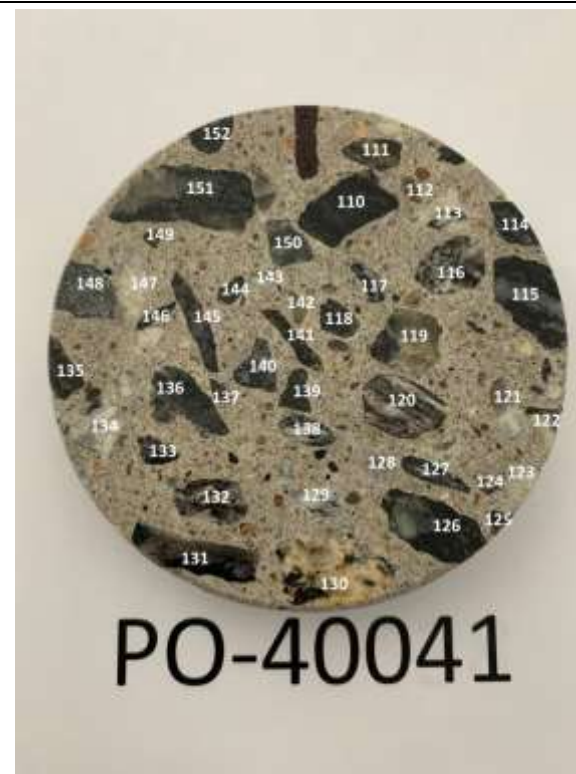
| Sulfide oxidation : | Moderate amounts of pyrrhotite oxidation and replacement iron oxides were observed in 16% of pyrrhotite-bearing coarse aggregates (13 of 80 particles), with no associated significant cracking distress. |
