# Foundation Assessment Municipal Pump Facility

40 Old Farms Road (Senior Way)  
Willington CT

prepared for  
**Town of Willington CT**

Project 19-163  
Approximate year constructed: 2004±

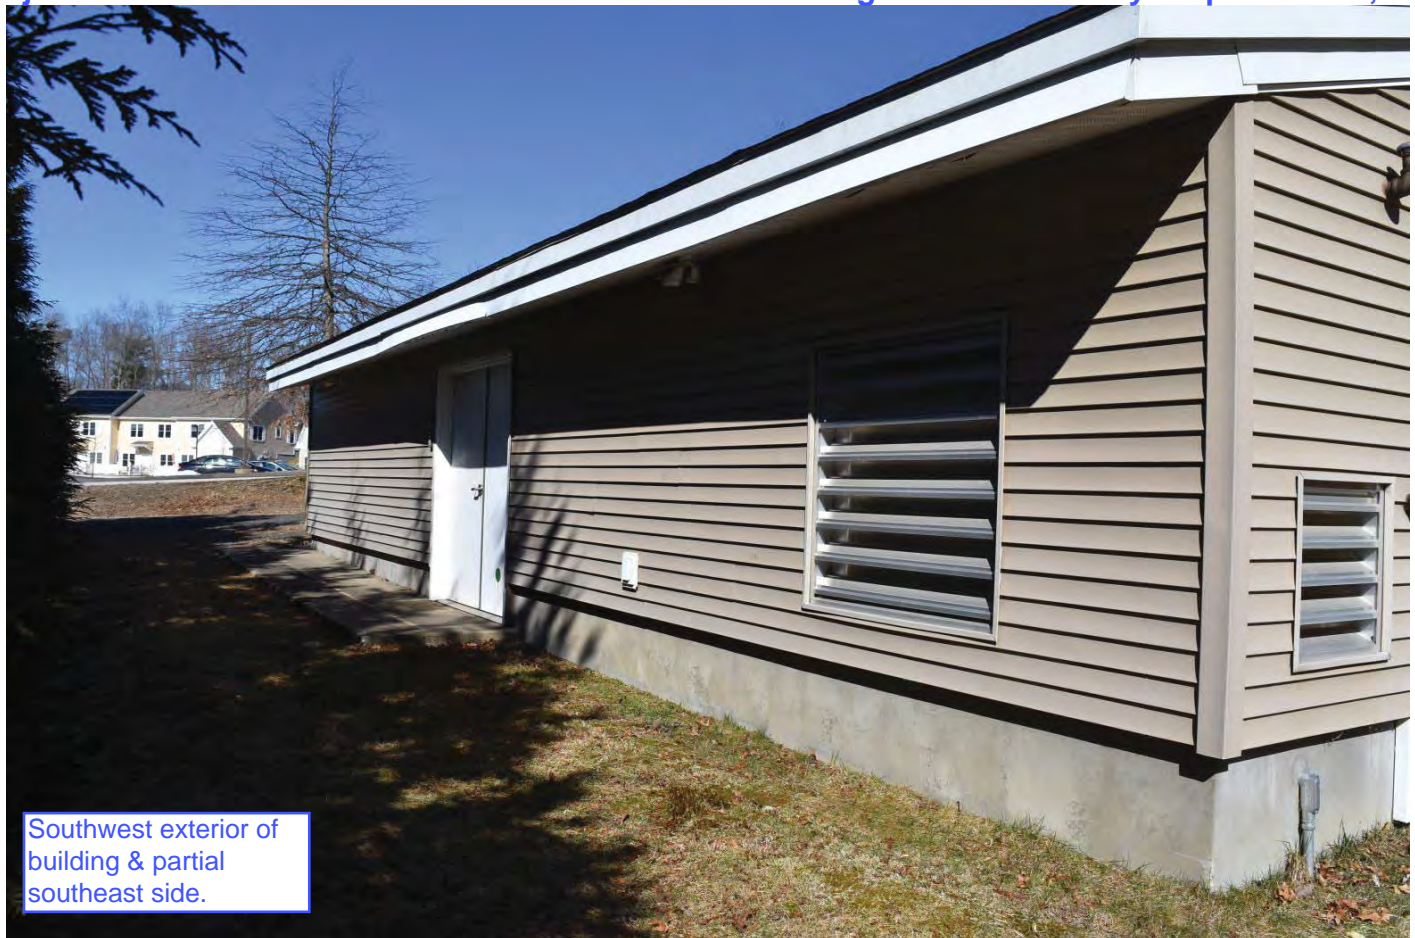
Photo 3

Southwest exterior of building & partial southeast side.

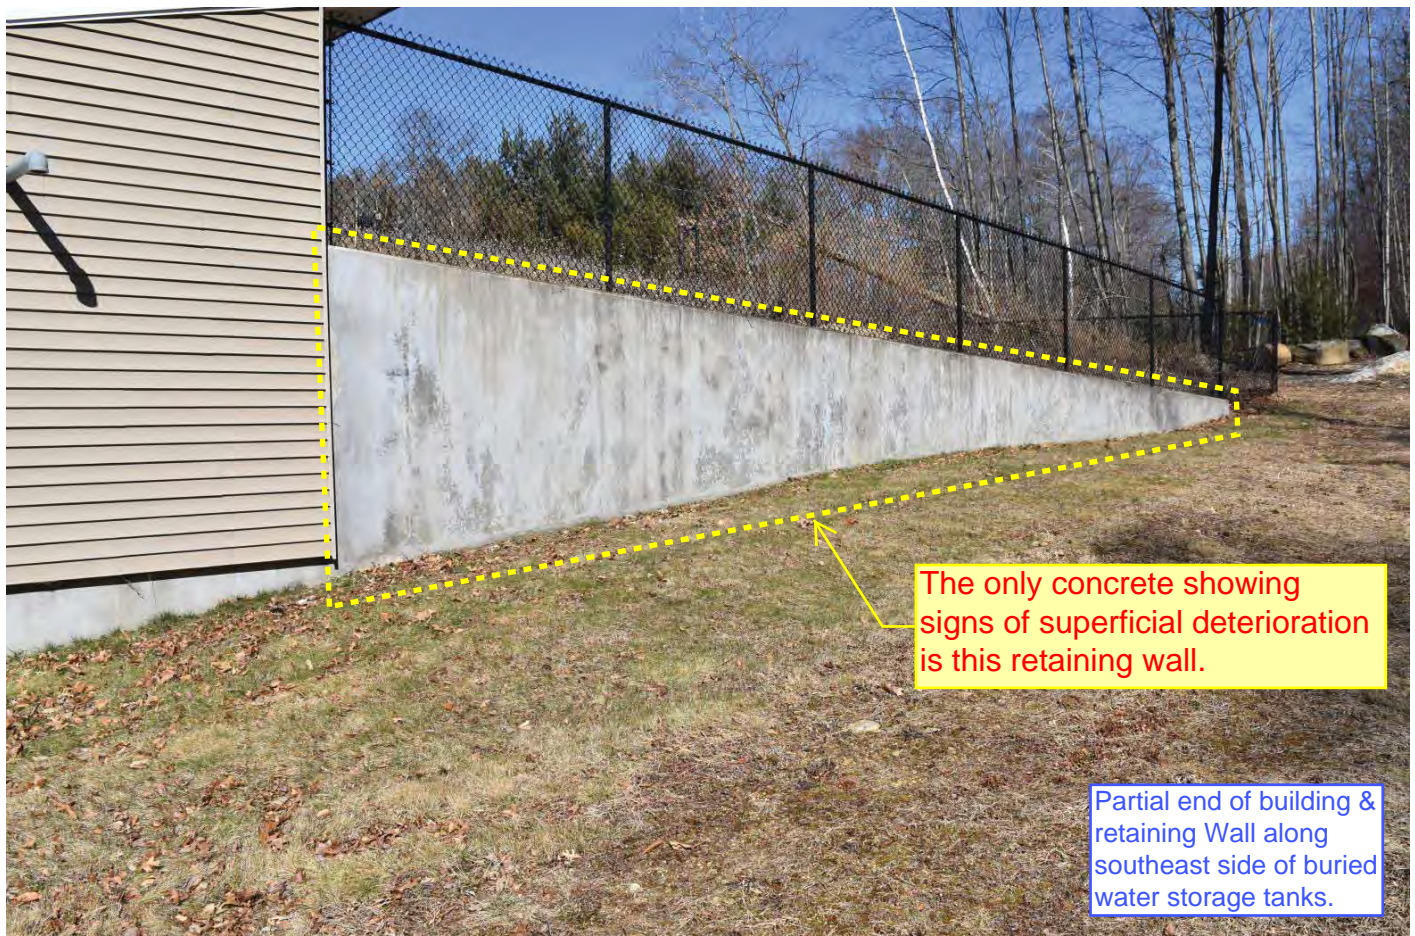
Photo 4

The retaining wall aligning with the southeast side of this structure currently exhibits poor adhesion of the parging to the underlying concrete wall. This degradation will continue as it experiences continued freeze-thaw cycles. Further, this water is exposed to moisture on both faces—the exposed face from rainwater, the earth-facing side from ground water that may penetrate the water-resisting coating. This wall is (or can be) independent of the building’s foundation. Should it exhibit continued deterioration over future years, and if its replacement becomes necessary, it should not have an impact on the functionality of this facility.

The only concrete showing signs of superficial deterioration is this retaining wall.

Partial end of building & retaining wall along southeast side of buried water storage tanks.

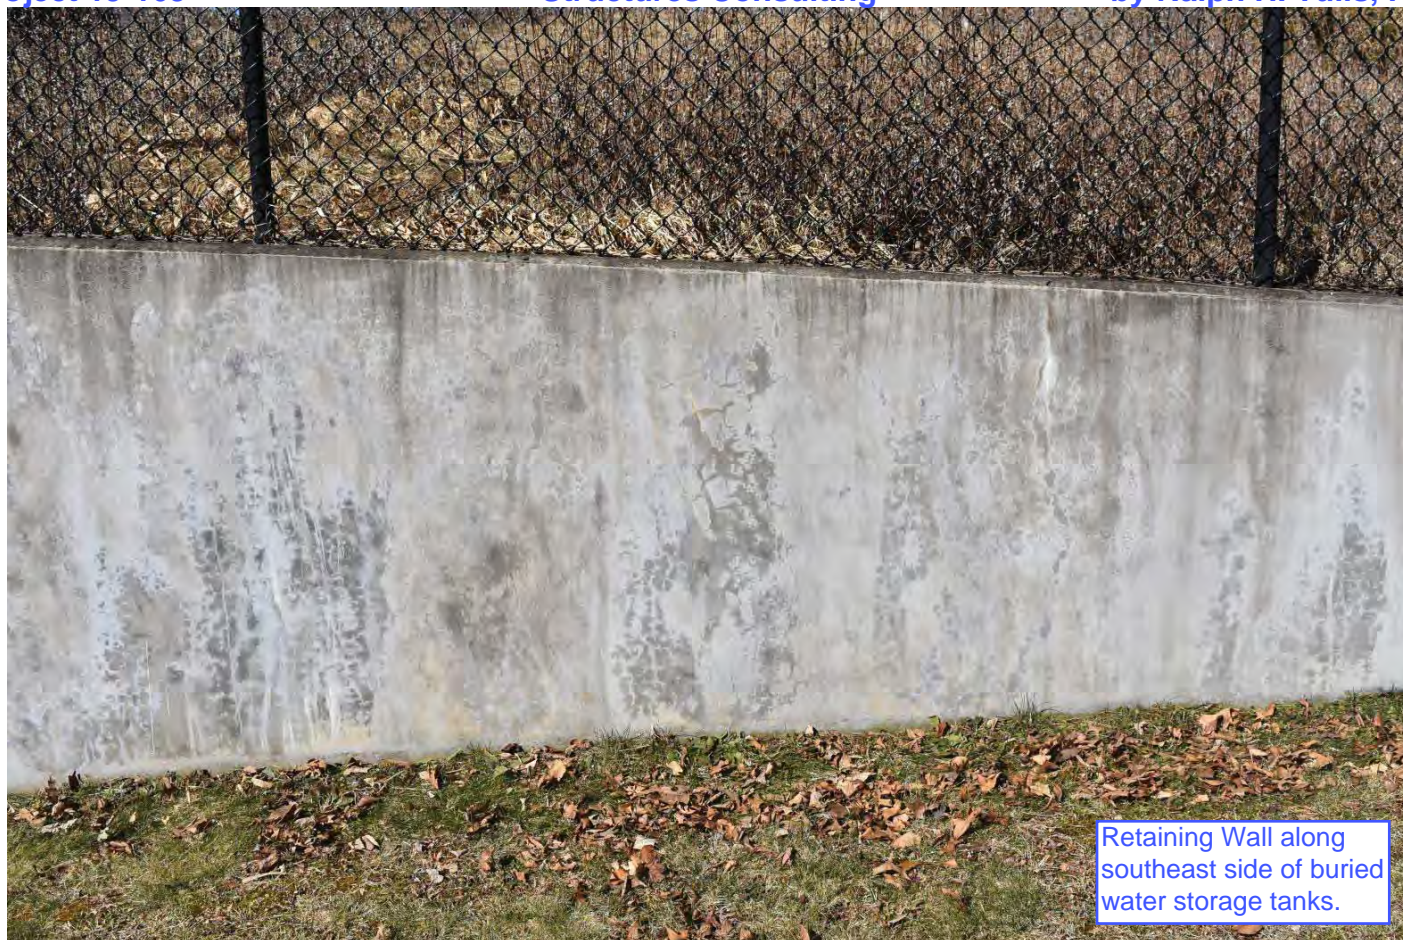
Photo 7

Retaining Wall along  
southeast side of buried  
water storage tanks.

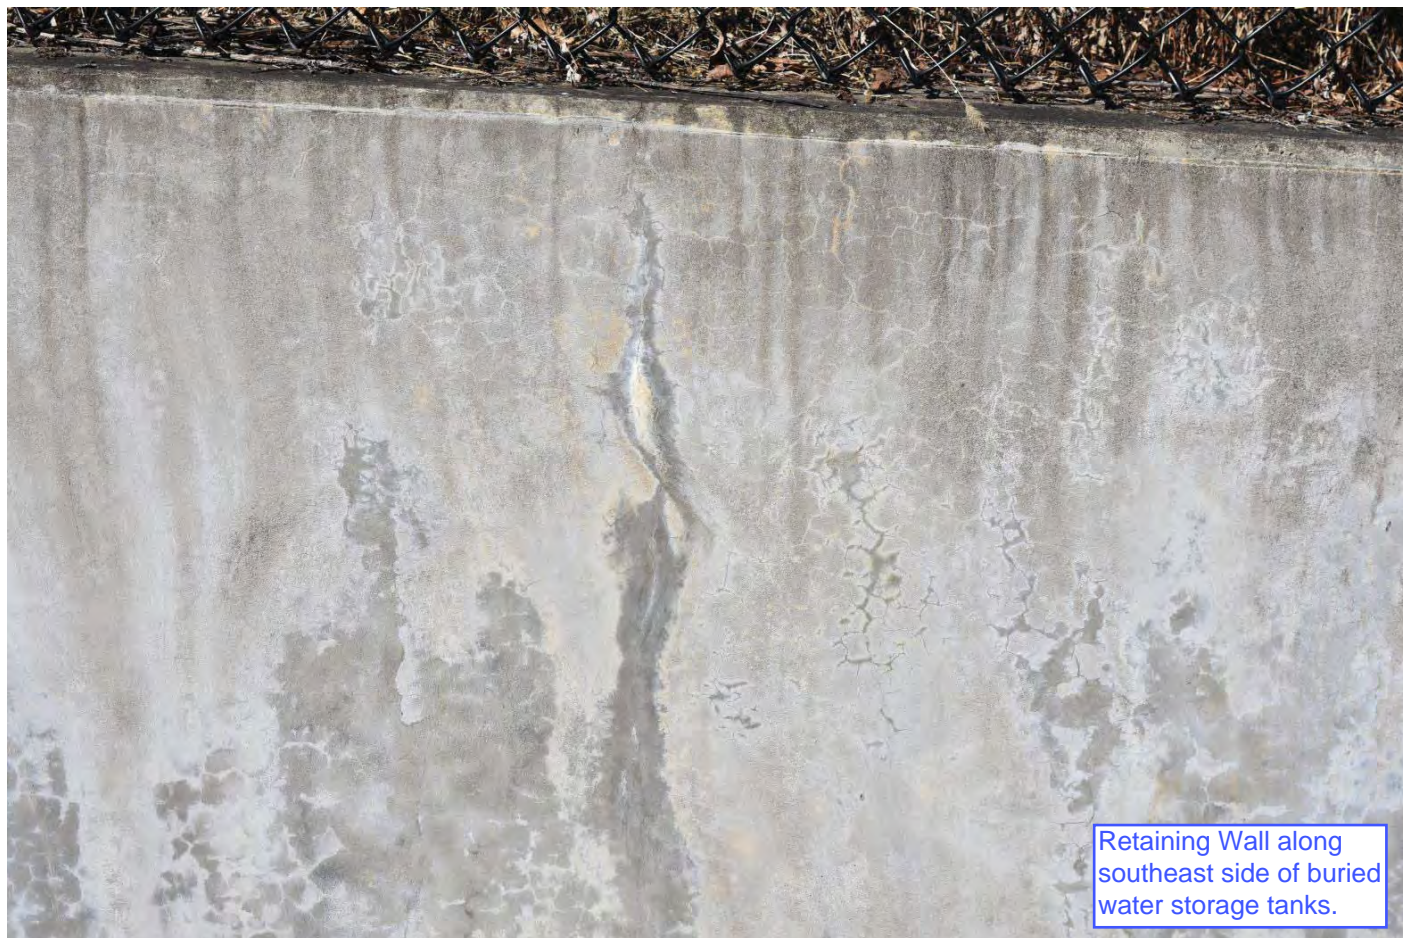
Photo 8

Retaining Wall along  
southeast side of buried  
water storage tanks.

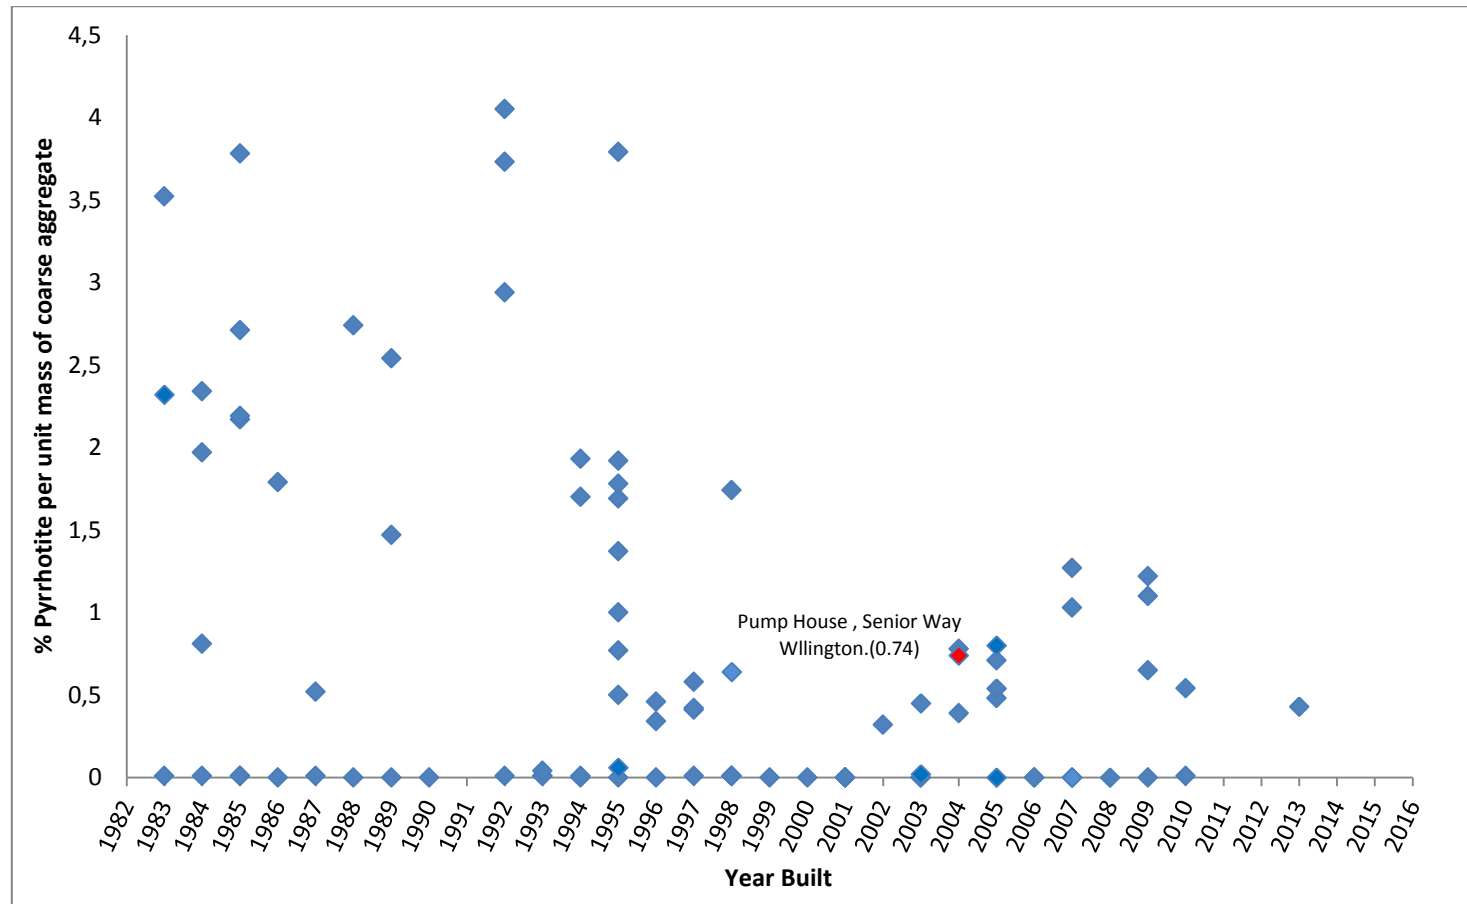
**Pyrrhotite Content (w%) versus Year Built in Connecticut and Massachusetts (February 4th, 2020)**

- **The estimated pyrrhotite content is 0.74% by mass of coarse aggregate.** This value is in the lower spectrum of values we have measured to date in Connecticut and Massachusetts (see graph on page 4)

The following graph shows the results obtained from all concrete foundations tested by Sedexlab to date in Connecticut and Massachusetts (February 4th 2020). Pyrrhotite content results are plotted versus the year of construction of the foundations. Pyrrhotite content of 0.74% obtained from the sample extracted from the foundation located at Pump House, Senior Way in Willington, CT (red diamond) falls in the lower spectrum of measured values.
