# Foundation Assessment Senior Center Building

40 Old Farms Road (20 Senior Way)  
Willington CT

prepared for  
**Town of Willington CT**

Project 19-163  
Approximate year constructed: 2004±

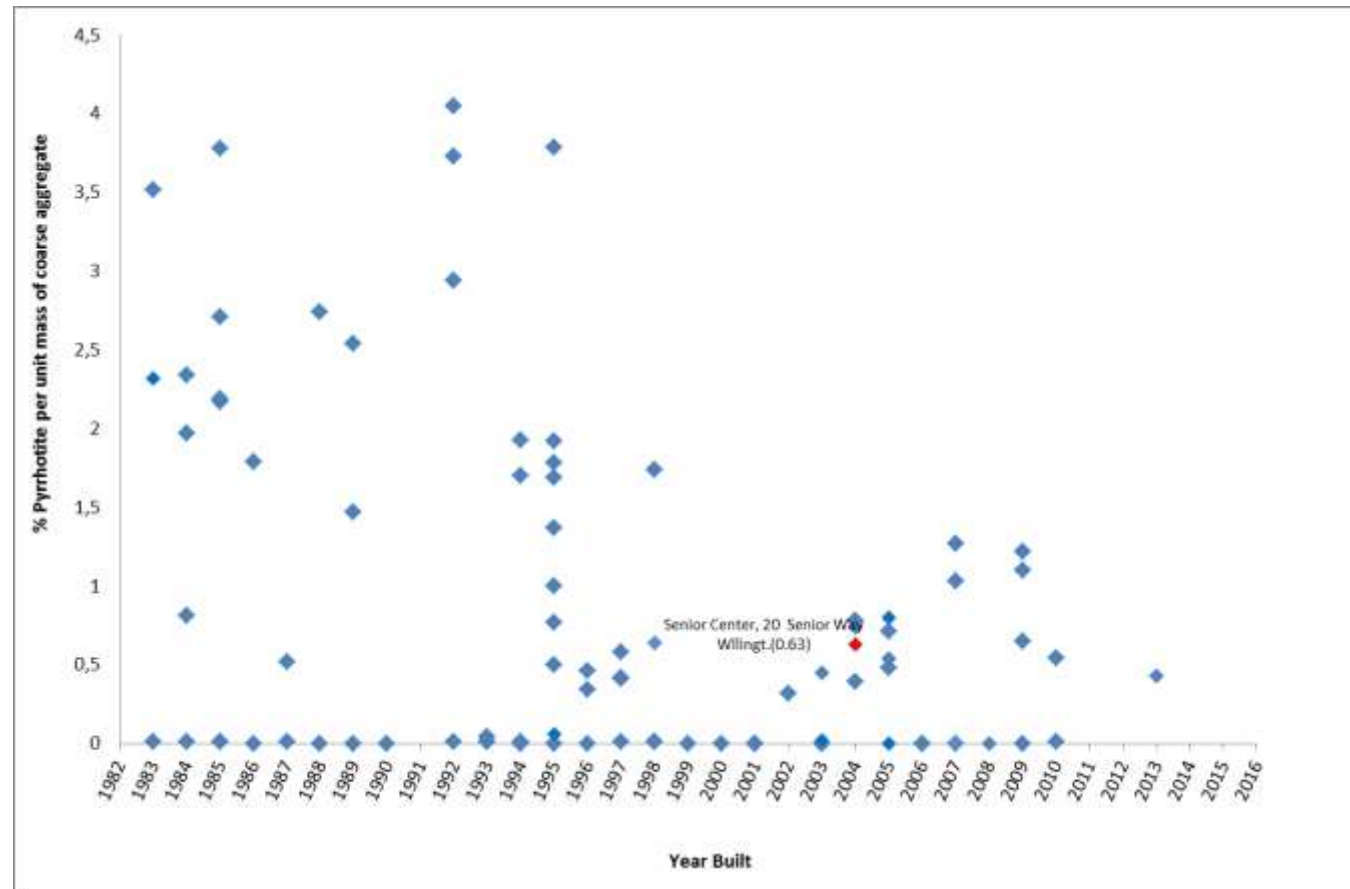
**Pyrrhotite Content (w%) versus Year Built in Connecticut and Massachusetts (February 4th, 2020)**

- **The estimated pyrrhotite content is 0.63% by mass of coarse aggregate.** This value is in the lower spectrum of values we have measured to date in Connecticut and Massachusetts (see graph on page 4)

The following graph shows the results obtained from all concrete foundations tested by Sedexlab to date in Connecticut and Massachusetts (February 4th 2020). Pyrrhotite content results are plotted versus the year of construction of the foundations. Pyrrhotite content of 0.63% obtained from the samples extracted from the foundation located at 20 Senior Way in Willington, CT (red diamond) falls in the lower spectrum of measured values.

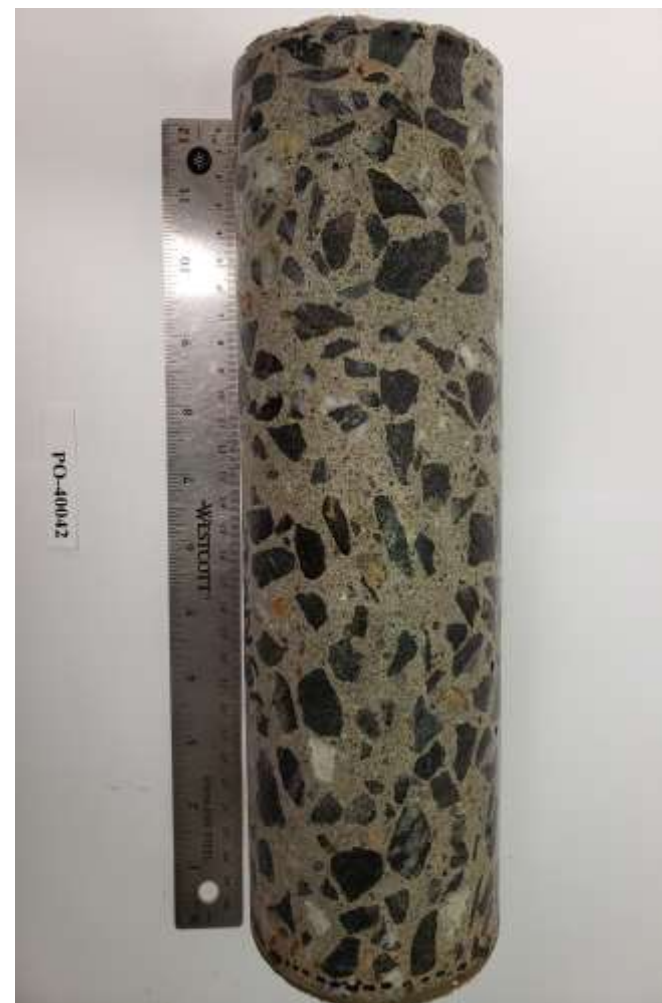
**Client :** Structures Consulting  
**Sedexlab project no :** AB-1009-006  
**Core ID :** 1-BW-MB-EXT  
**Sedexlab ID :** PO-40042

Visible iron sulfides: Disseminated  
Magnetism : Weak to moderate  
Oxidation/alteration: Trace

General condition : Good  
Spalling : none  
Delaminating : none  
Cracking: none  
Aggregate/paste bond: Good

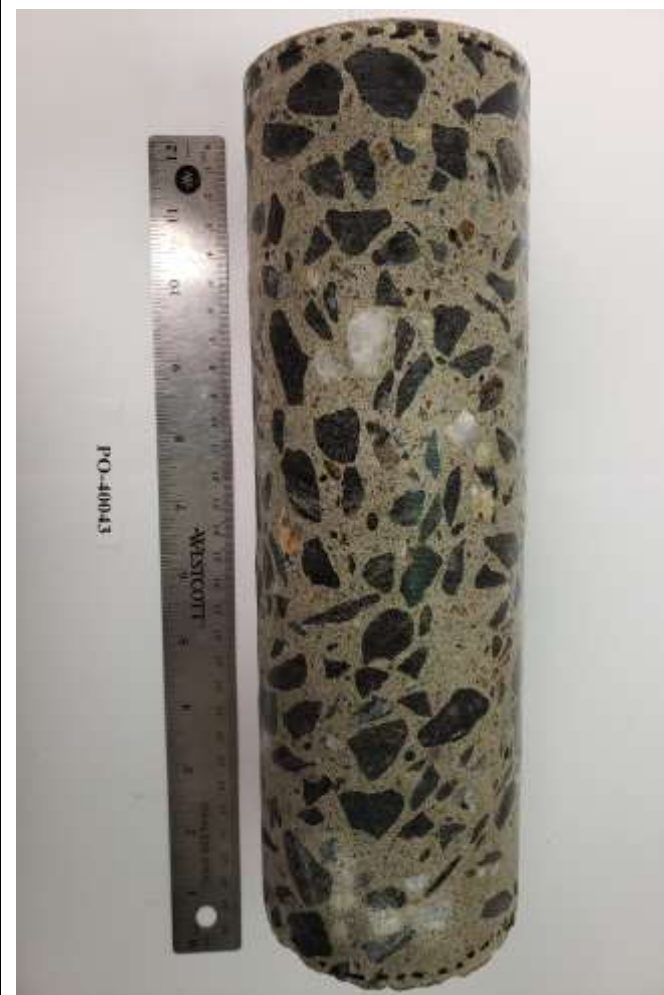
Visible iron sulfides: Disseminated  
Magnetism : Weak  
Oxidation/alteration: Trace

General condition : Good  
Spalling : none  
Delaminating : none  
Cracking: none  
Aggregate/paste bond: Good

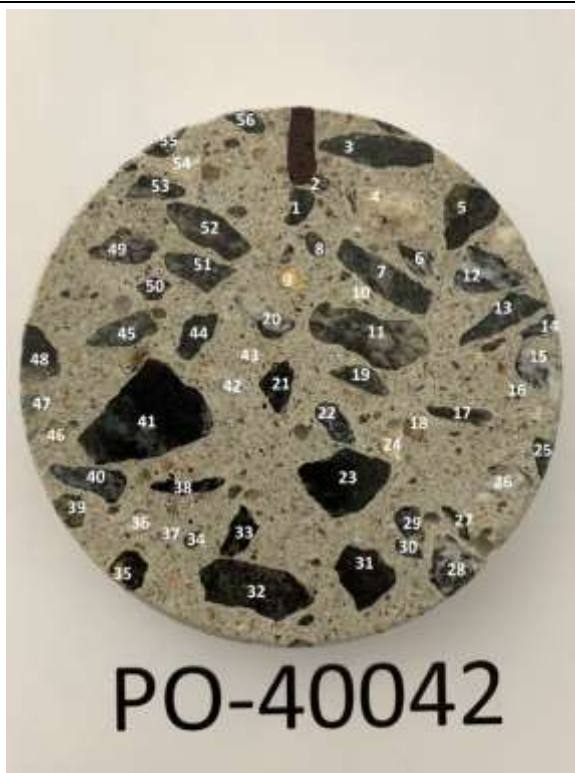
PO-40042

<b>Total number of coarse aggregates :</b>	108 (two sections combined)
<b>Coarse aggregate composition (avg%) :</b>	Granitic gneiss (73), quartzite (13) granite (12) and diabase (2)
<b>% pyrrhotite-bearing aggregates :</b>	54% (58 of 108 particles)
<b>% higher potential reactivity aggregates:</b>	11% (12 of 108 particles)
<b>Iron Sulfide composition :</b>	Pyrrhotite (99%) Pyrite (0%), Chalcopyrite (1%)
<b>Sulfide oxidation :</b>	Low amounts of pyrrhotite oxidation and replacement iron oxides were observed in 12% of pyrrhotite-bearing coarse aggregates (7 of 58 particles), with no associated significant cracking distress.
