Re: Consumer Protection Investigation of Crumbling Concrete Home Foundations

INVESTIGATING THE DETERIORATION OF BASEMENT WALLS MADE OF CONCRETE IN CT

Kay Wille¹ and Rui Zhong²

University of Connecticut

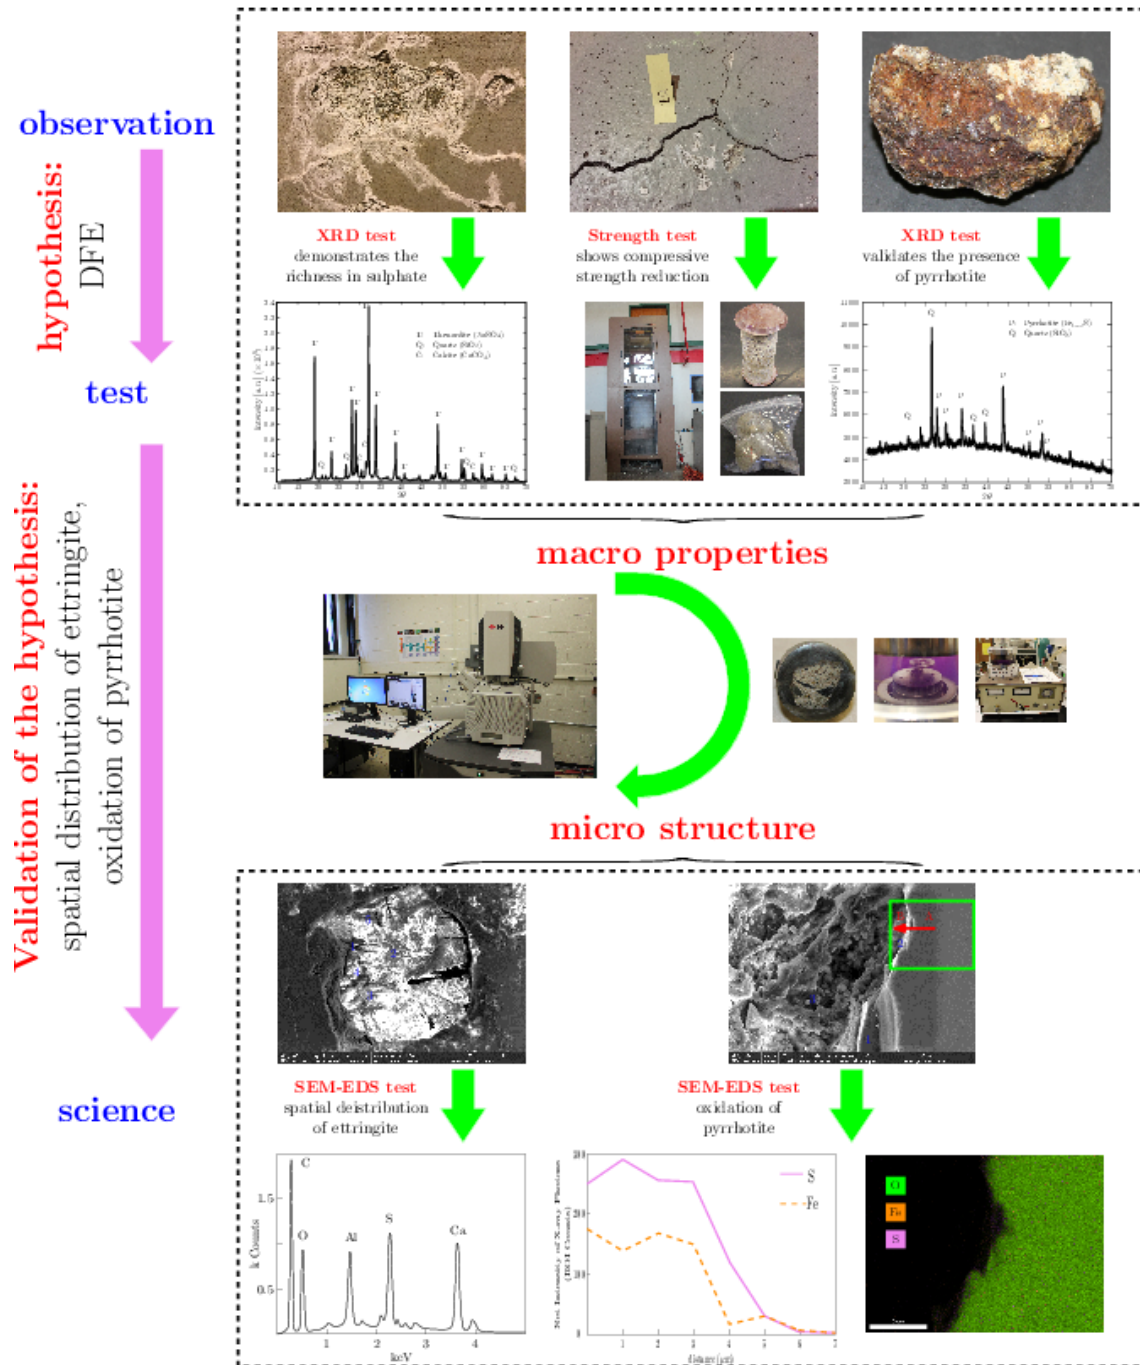
Fig. 1.1 Research Approach

Fig. 1.1 schematically summarizes the research approach, in which visible macroscopic properties are linked to scientific microstructural parameters.

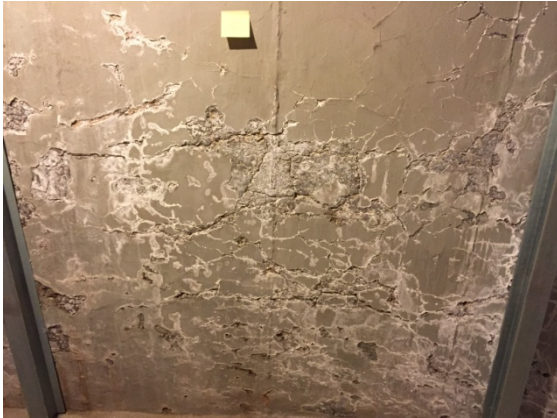
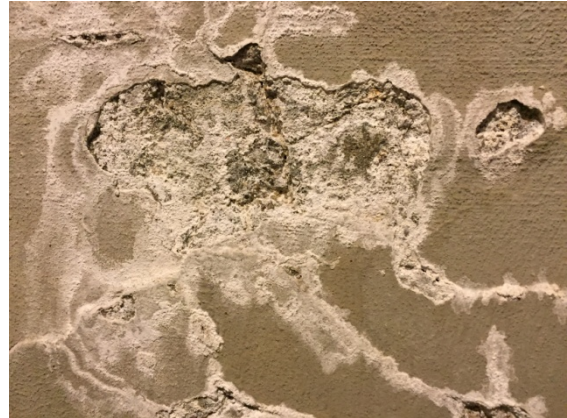
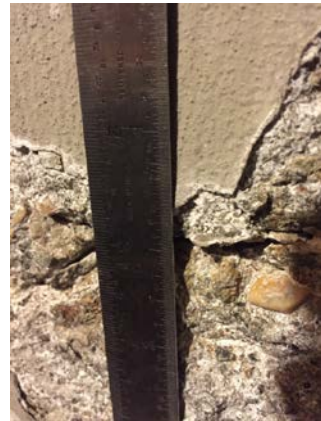
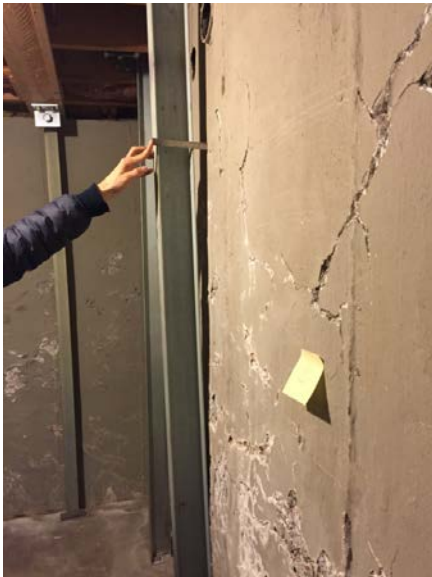
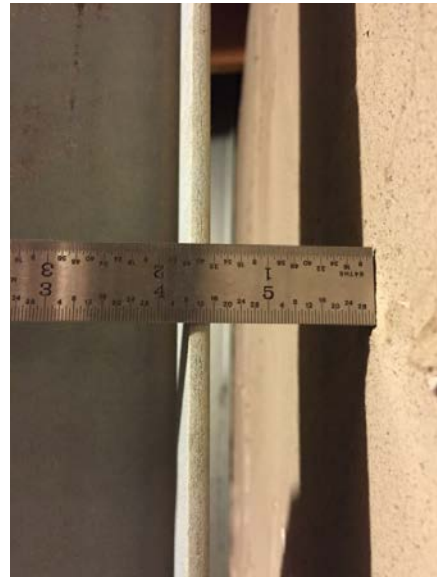
Fig. 3.2 Typical symptoms of deteriorated foundation

- map cracking with wide opening and/or significant deformation of the wall
- whitish formation of minerals at the vicinity of cracking surface
- reddish - brown discoloring

a) map cracking

b) Abundant whitish powder

c) reddish – brown discoloring

d) crack opening (>4mm)

e) significant deformation of the concrete foundation wall

Since the inspected houses where core samples were taken show similar symptoms, only visual inspection was conducted for additional 14 houses. Soil samples were also taken and examined in the soil laboratory at the University of Connecticut.

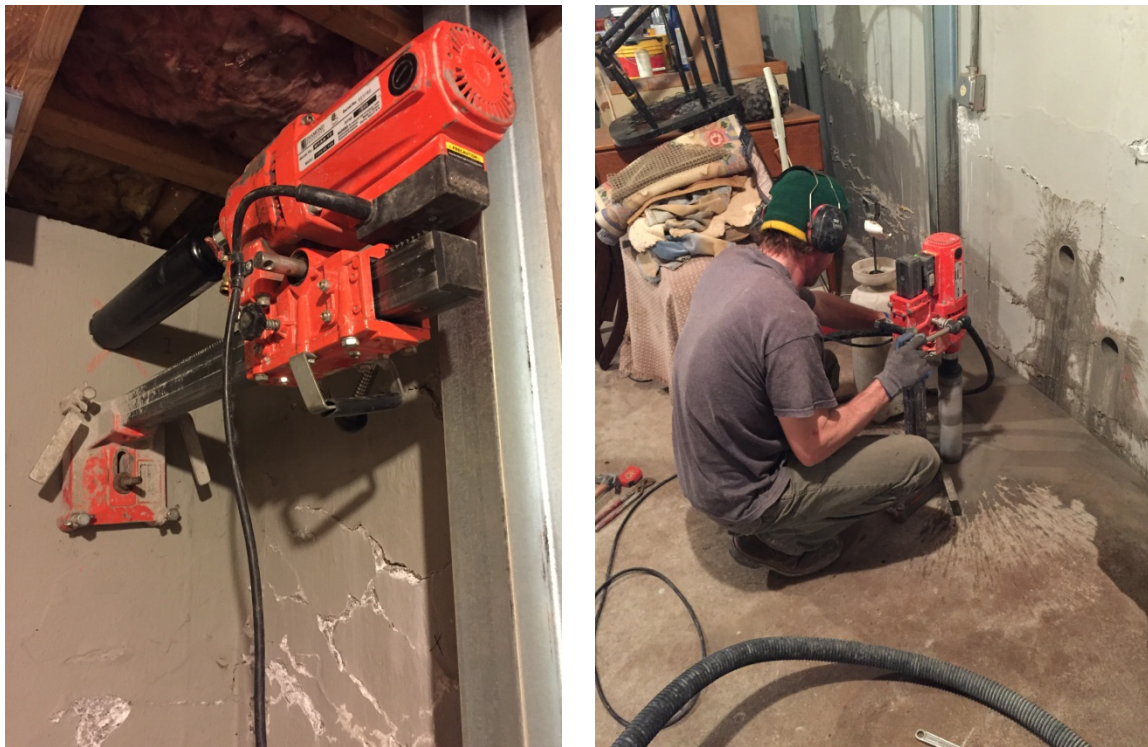
Cylinder cores with a diameter of 3 inch and a minimum length of 6 inch were drilled out of the walls both at relatively intact and deteriorated areas for compressive strength test. The lengths of the cores drilled out of slabs were restrained by the actual thickness of the slab and ranged from 3 to 4 inches. An experienced third party contractor was hired to carry out the coring process (**Fig. 4.1**). In general, at least 9 concrete samples were cored from the foundation wall of each house.

Fig. 4.1 Coring process carried out by a third party contractor

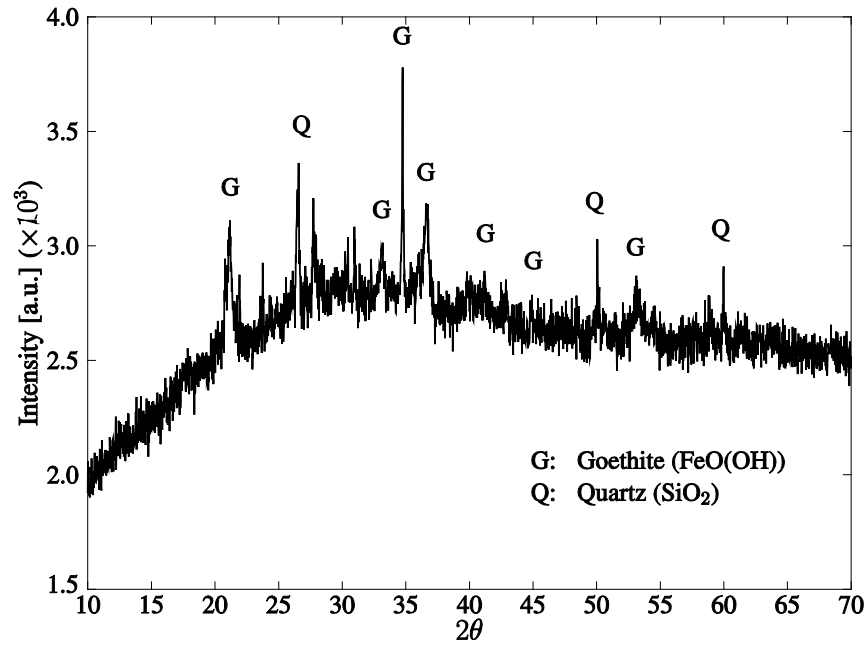
Fig. 6.5 XRD pattern of aggregate showing the oxidization product of goethite

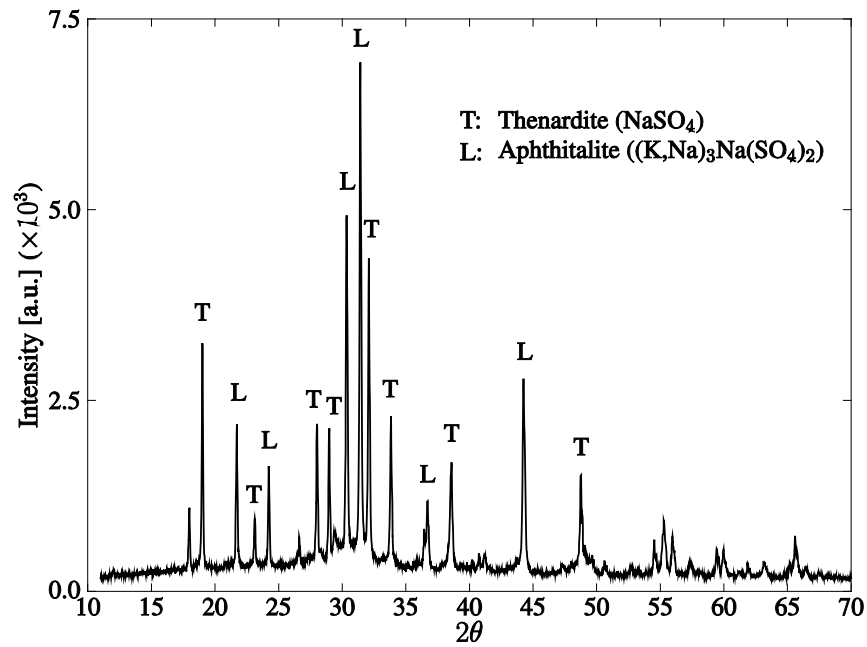
Typical XRD patterns of the whitish formation at the vicinity of cracking surface are present in **Fig. 6.6** and **Fig. 6.7**. It can be seen that quartz (Q) and calcite (C) are detected. This is attributable to remains of aggregate particles mixed with the whitish formation during sample preparation (**Fig. 6.1b**). In addition, gypsum is also observed. This is attributable to the remains of cement matrix during the scratching process of sample preparation. Therefore sulfate rich thenardite (T) and apththitalite (L) are considered as the primary mineral phases in this whitish powder. The source of sulfate in thenardite and apththitalite is potentially the released sulfate during the oxidization process of pyrrhotite. It is worth noting that three samples from each inspected houses were tested if enough whitish formation was obtained. Most of the samples demonstrated the existence of sulfate rich minerals such as thenardite (T) or apththitalite (L) or both. This finding suggests the oxidization of pyrrhotite-bearing aggregate and the potentially delayed formation of minerals such as ettringite and thaumasite.

Fig. 6.7 Typical XRD pattern of whitish formation – housing 7

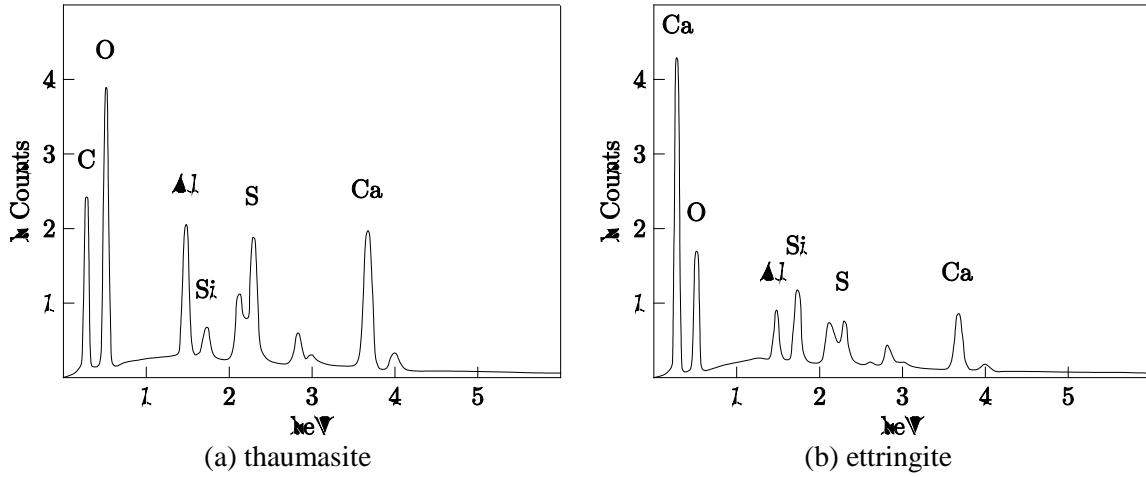
Fig. 7.16 EDX result for the minerals in void A

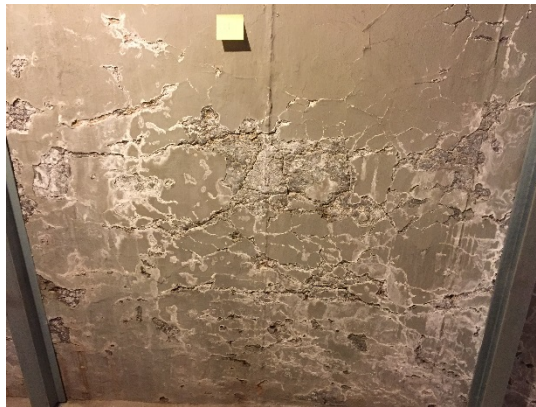
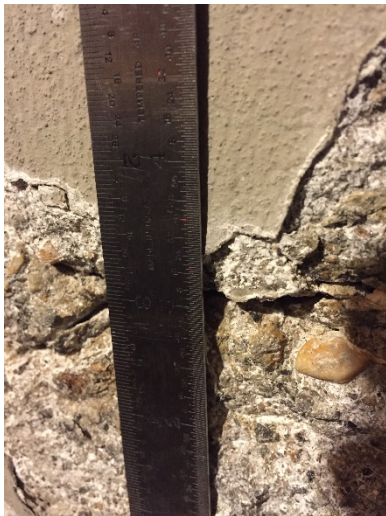
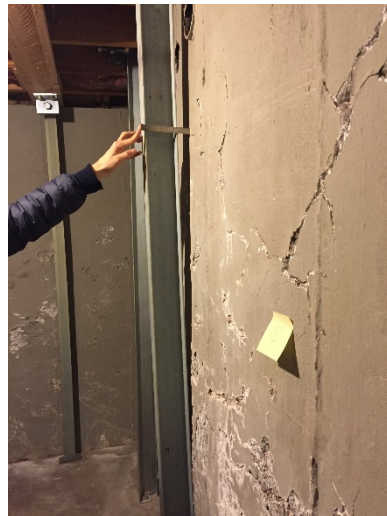
Fig. A- 1 House 1

(a) whitish powder

(b) brown trace

(c) map cracking

(d) wide crack opening

(e) large deformation

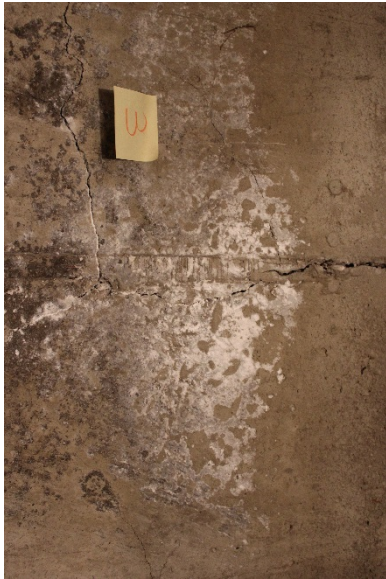
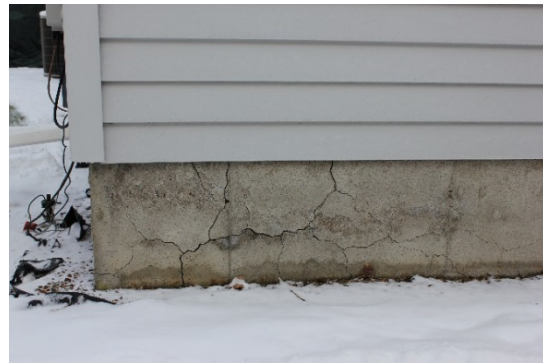
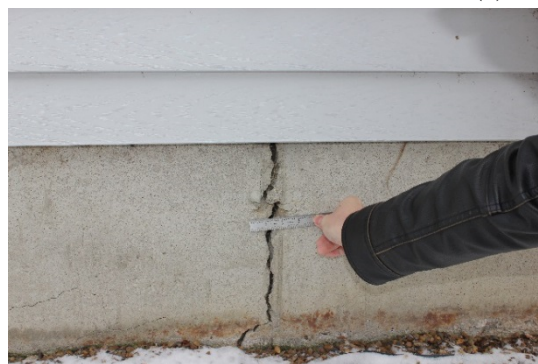
Fig. A- 3 House 3

(a) whitish powder

(b) brown trace

(c) map cracking

(d) wide crack opening

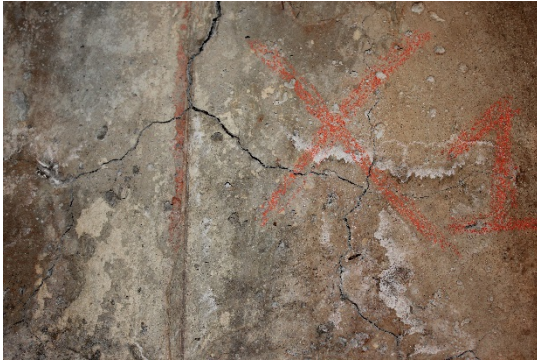
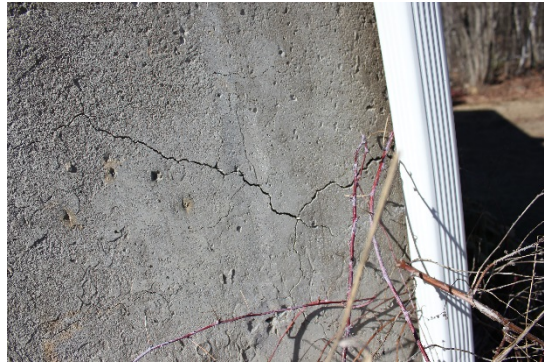
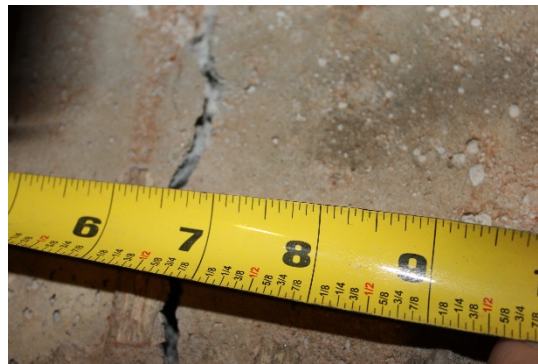
Fig. A- 4 House 4

(a) whitish powder

(b) brown trace

(c) map cracking

(d) wide crack opening

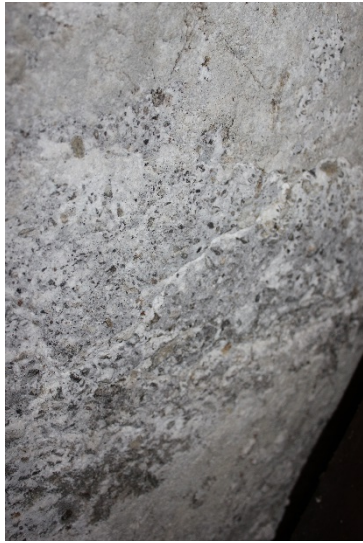
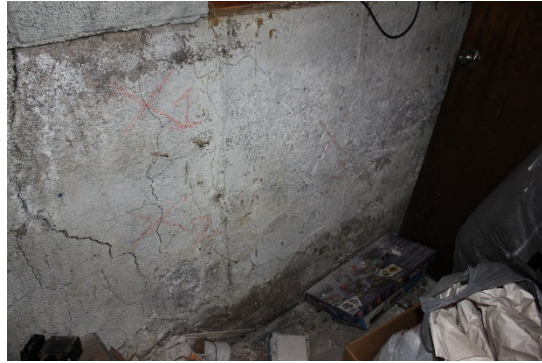
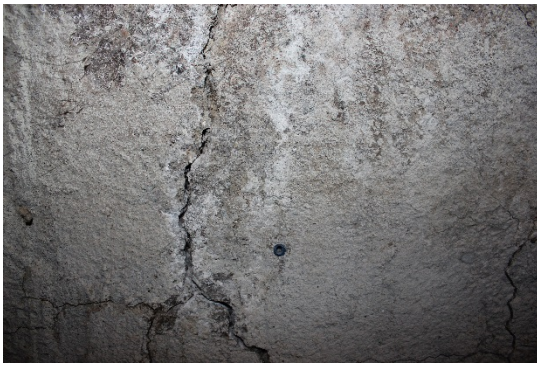
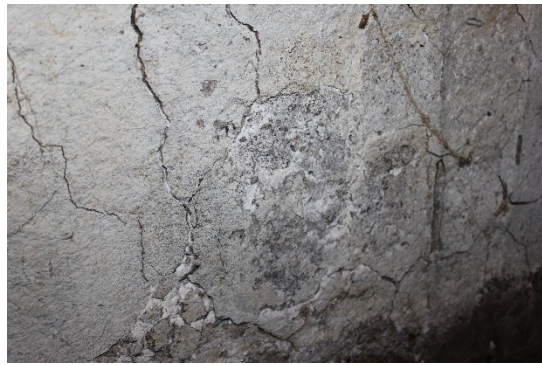
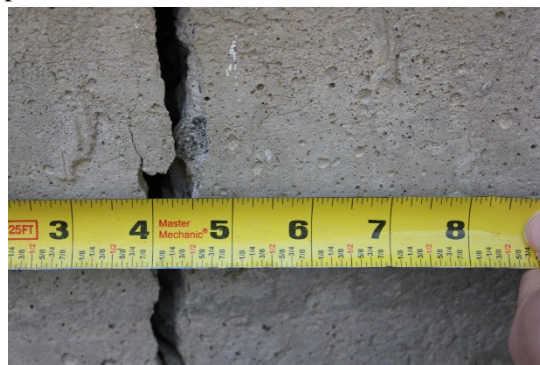
Fig. A- 5 House 5

(a) whitish powder

(c) map cracking

(d) wide crack opening

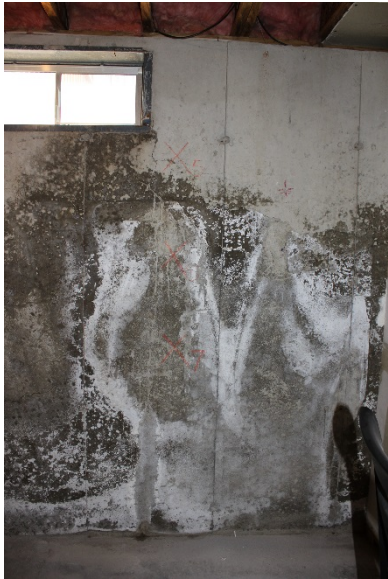
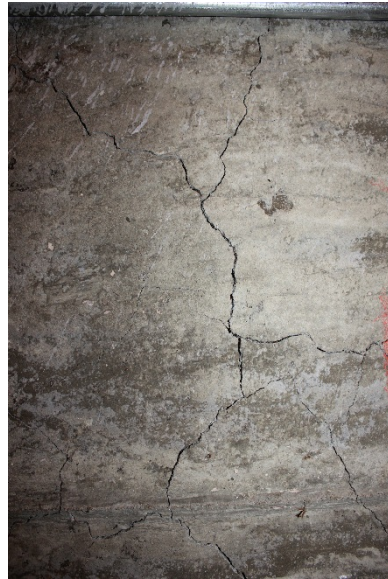
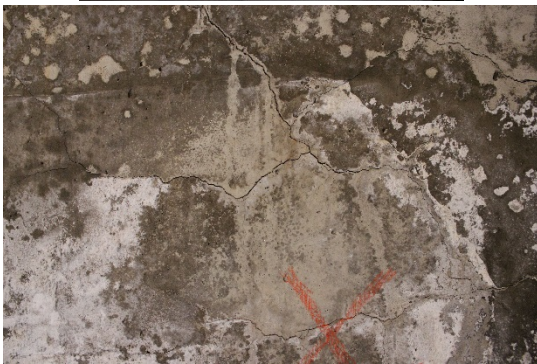
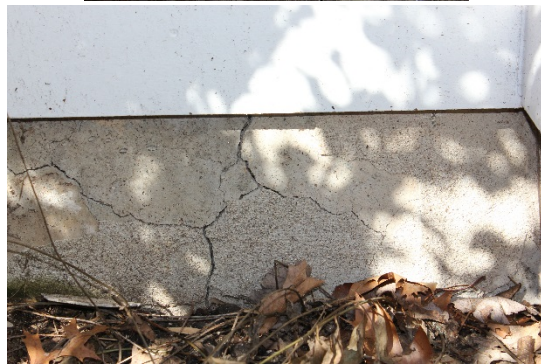
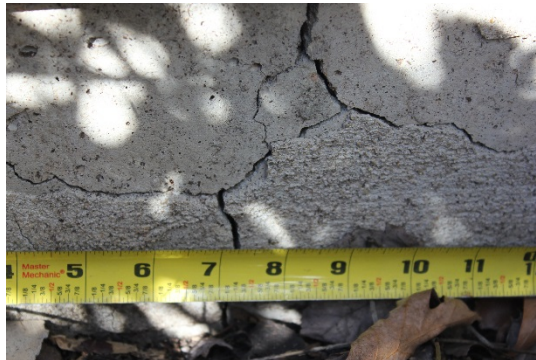
Fig. A- 6 House 6

(a) whitish powder

(b) map cracking

(c) wide crack opening
