Willington Municipal Facilities Study

WILLINGTON, CT
DECEMBER 3, 2013

In 2009, Kaestle Boos Associates reviewed existing conditions of the following facilities:

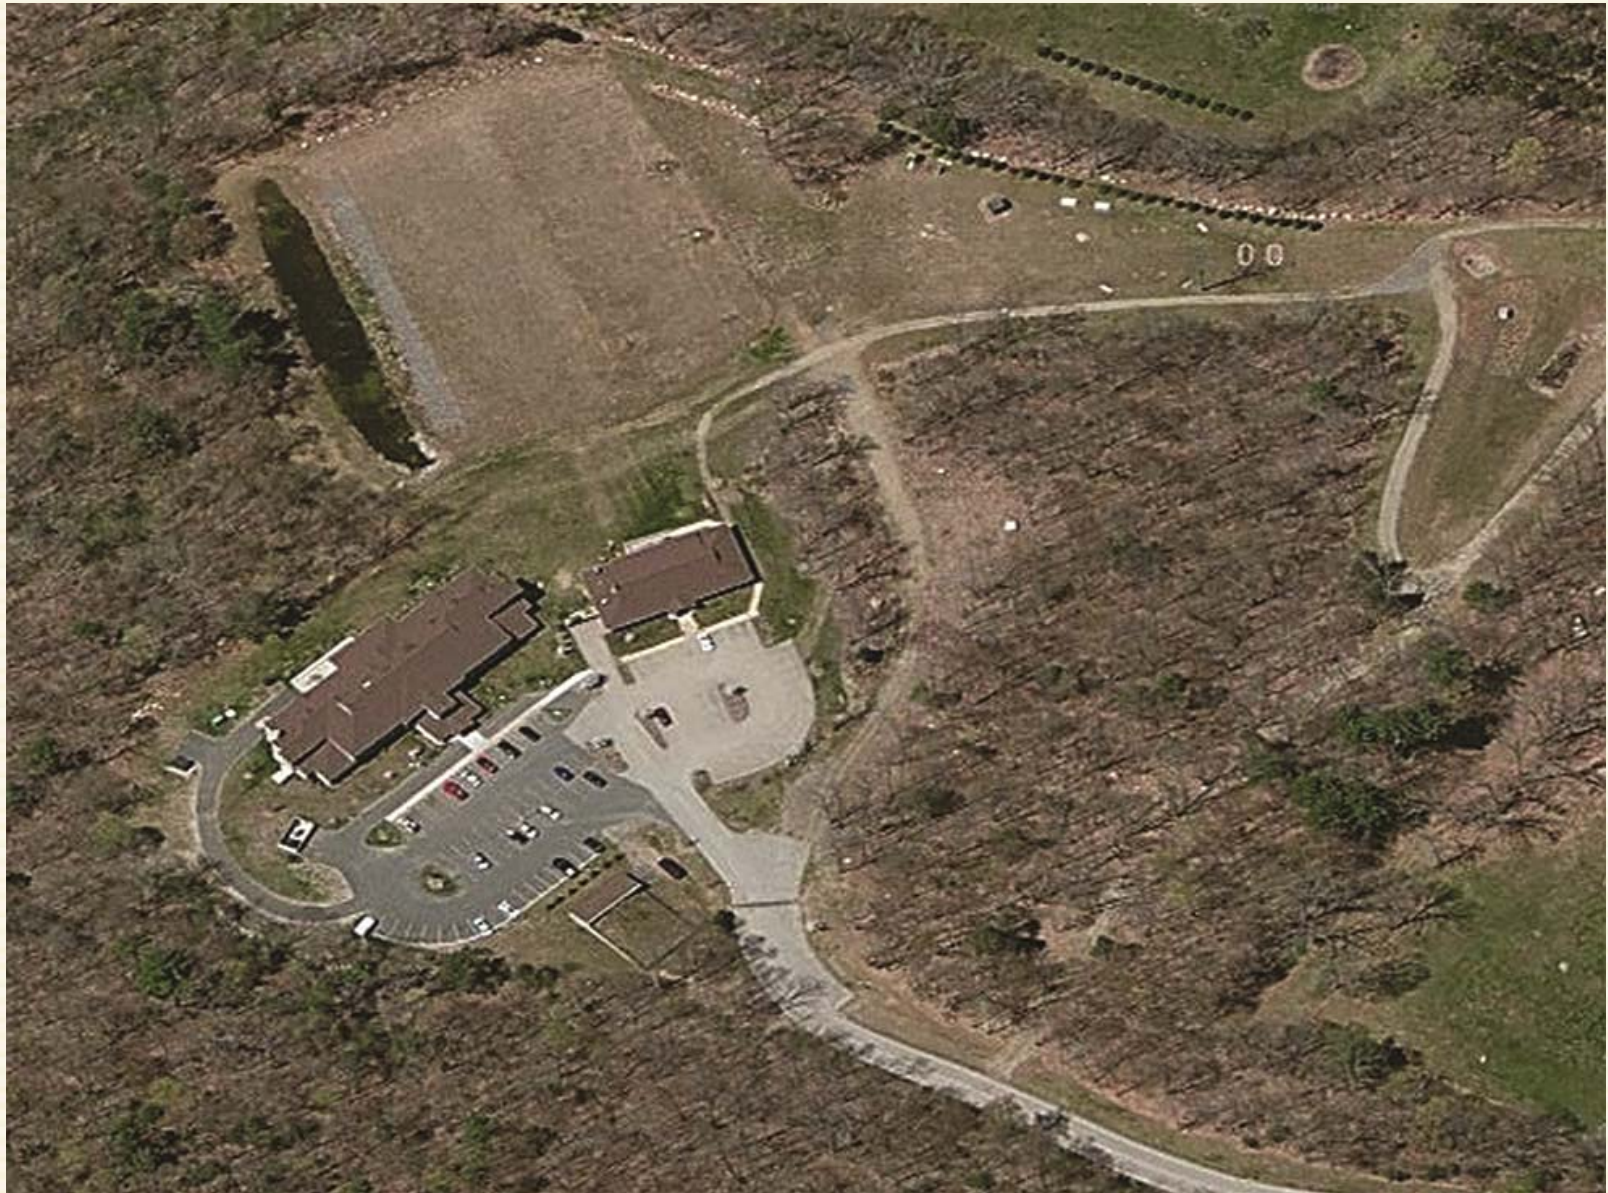
Willington Senior Center

- ❖ Repair fitting at kitchen sink and provide grease interceptor
- ❖ Handicapped accessibility lacking at sinks and cabinets
- ❖ Seating is limited for large functions
- ❖ Storage is limited

- Provide automatic sprinkler protection for the entire facility
- Repair fitting at kitchen sink and provide grease interceptor
- Alter sinks and cabinets to provide handicapped accessibility
- Expand Great Room for additional seating
- Expand and alter restrooms, replace fixtures to conserve water
- Expand Kitchen
- Provide additional storage space at lower level
- Upgrade air handling units to increase efficiency
- Provide additional Parking
- Upgrade septic system
- Restripe handicapped parking spaces and install bollards

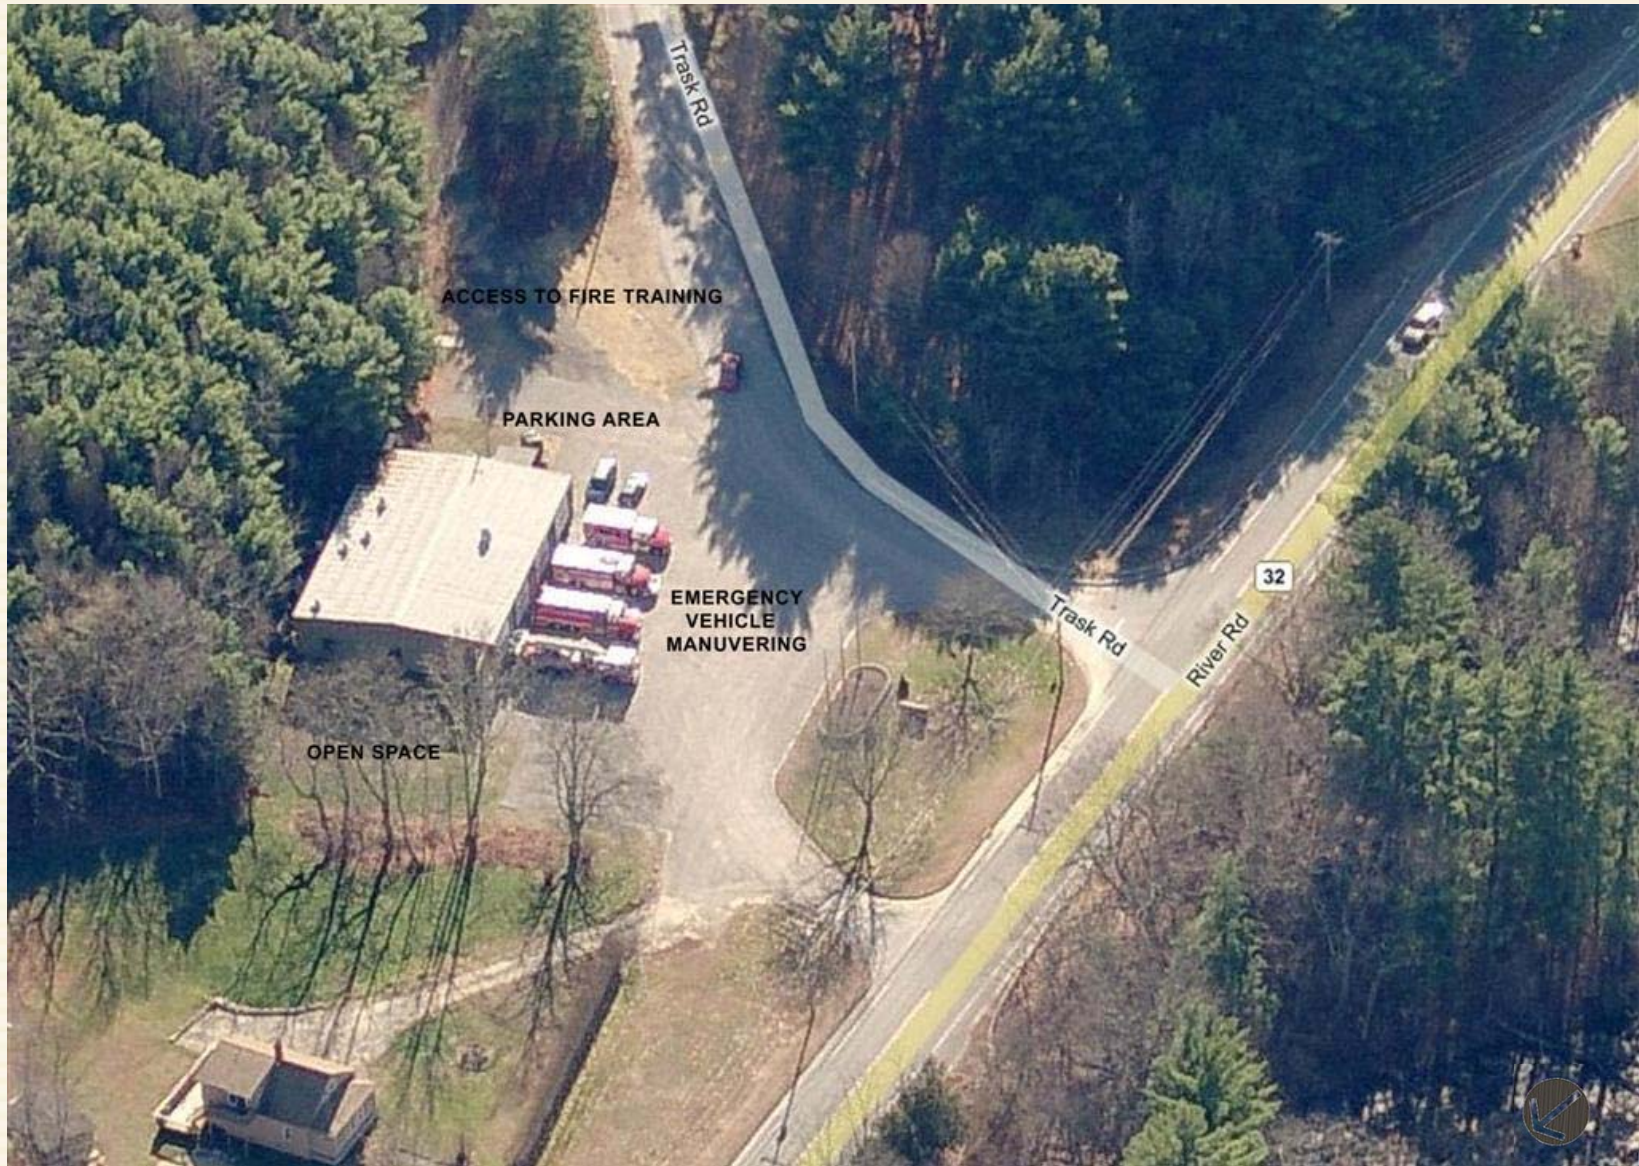
Fire Department #1 (Station 13)

- ❖ Kitchen lacks exhaust hood, make up air, and fire suppression system
- ❖ Kitchen lacks grease interceptor
- ❖ Plumbing fixtures are not water-conserving type
- ❖ Pipe insulation is lacking
- ❖ Backflow preventers and air gap fittings are missing
- ❖ Finned-tube radiation is in poor condition
- ❖ Exhaust fans are in poor condition
- ❖ Air conditioning is in poor condition
- ❖ Electrical service is in poor condition

- ❖ Internal communication panel is in poor condition
- ❖ Lighting, emergency lighting, and exit signs are in poor condition
- ❖ Doors and windows are not energy efficient
- ❖ Handicapped accessibility is lacking at doors, plumbing fixtures, counters, locker rooms, signage, and parking spaces
- ❖ Additional space is needed for apparatus bays, day room, lockers, bunks, training, and support spaces

- Construct an addition to meet programmatic needs
- Provide exhaust hood, make up air, and fire suppression system for kitchen
- Provide grease interceptor
- Alter toilet rooms to be accessible and provide water-conserving fixtures
- Provide backflow preventers and air gap fittings
- Replace air-conditioning equipment and finned-tube radiation
- Replace exhaust systems
- Replace electrical system
- Replace internal communication panel
- Provide new fire alarm system
- Upgrade lighting
- Replace emergency lighting and exit signs
- Replace doors and windows
- Alter doors, toilet rooms, counters, locker rooms, and parking to provide handicapped accessibility
- Provide room identification signage

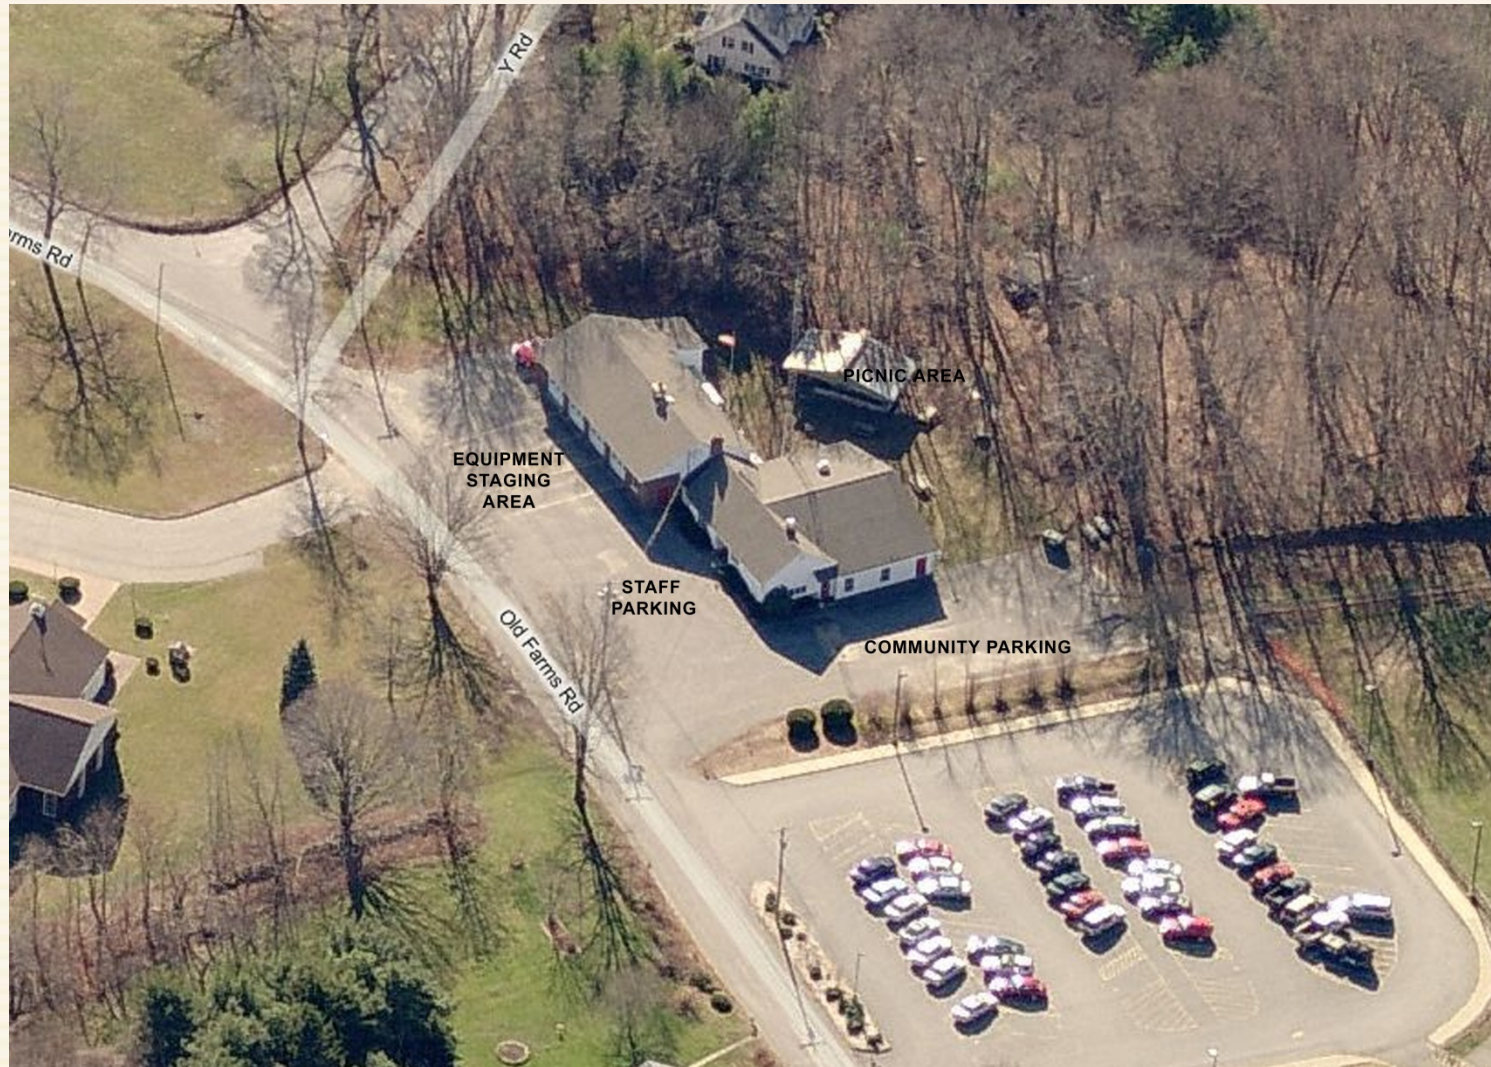
Willington Hill Fire Department

- ❖ Parking spaces are not defined
- ❖ Pavement is in disrepair
- ❖ Outdoor storage is needed
- ❖ Roof has exceeded life expectancy
- ❖ Additional space is needed for apparatus bays, offices, day room, lockers, bunks, exercise, and support spaces
- ❖ Site constraints limit expansion

- ❖ Electrical service, panels and generator are in poor condition
- ❖ Fire alarm system lacks monitoring
- ❖ Apparatus bays lack heat detectors and fire alarm pull stations
- ❖ Emergency lighting and exit signs are in poor condition
- ❖ Building lacks exhaust systems
- ❖ Kitchen lacks required make up air
- ❖ Kitchen lacks grease interceptor
- ❖ Apparatus bays lack oil separator
- ❖ Handicapped accessibility is limited

- Upgrade emergency lighting, exit signs, and fire alarm
- Provide exhaust systems
- Provide make up air for kitchen
- Alter stair railings
- Provide grease interceptor and oil separator
- Upgrade plumbing fixtures and provide kitchen hand sink
- Provide automatic sprinkler protection for the entire facility
- Alter doors, plumbing fixture arrangement, and counters to provide handicapped accessibility
- Provide inclined wheelchair lift for accessibility
- Provide room signage
- Delineate parking spaces and repair/replace paved surfaces
- Provide outdoor storage
- Replace roof
- Provide new air-conditioning units
- Replace electrical service
