Foundation Assessment Willington Public Library

7 Ruby Road (Route 320)
Willington CT

prepared for
Town of Willington CT

Project 19-163

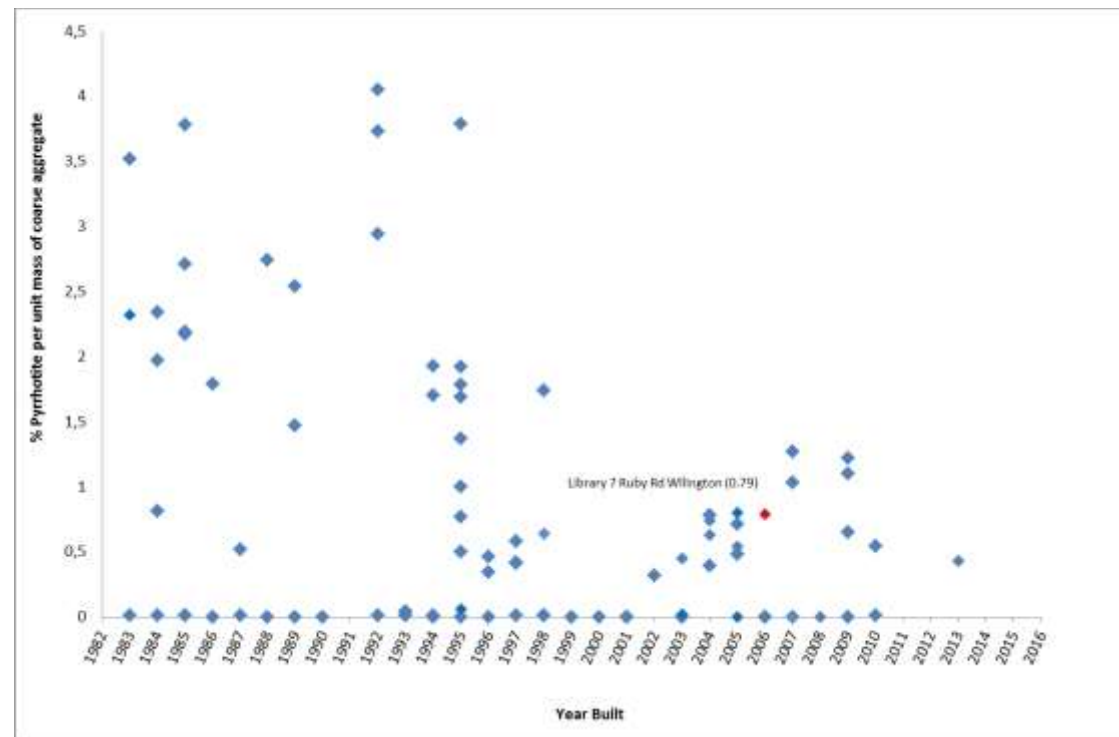
Pyrrhotite Content (w%) versus Year Built in Connecticut and Massachusetts (February 4th, 2020)

The following graph shows the results obtained from all concrete foundations tested by Sedexlab to date in Connecticut and Massachusetts (February 4th 2020). Pyrrhotite content results are plotted versus the year of construction of the foundations. Pyrrhotite content of 0.79% obtained from the samples extracted from the foundation located at 7 Ruby Road in Willington, CT (red diamond) falls in the lower spectrum of measured values.
