# Foundation Assessment Municipal Pump Facility

40 Old Farms Road (Senior Way)  
Willington CT

prepared for  
**Town of Willington CT**

Project 19-163  
Approximate year constructed: 2004±

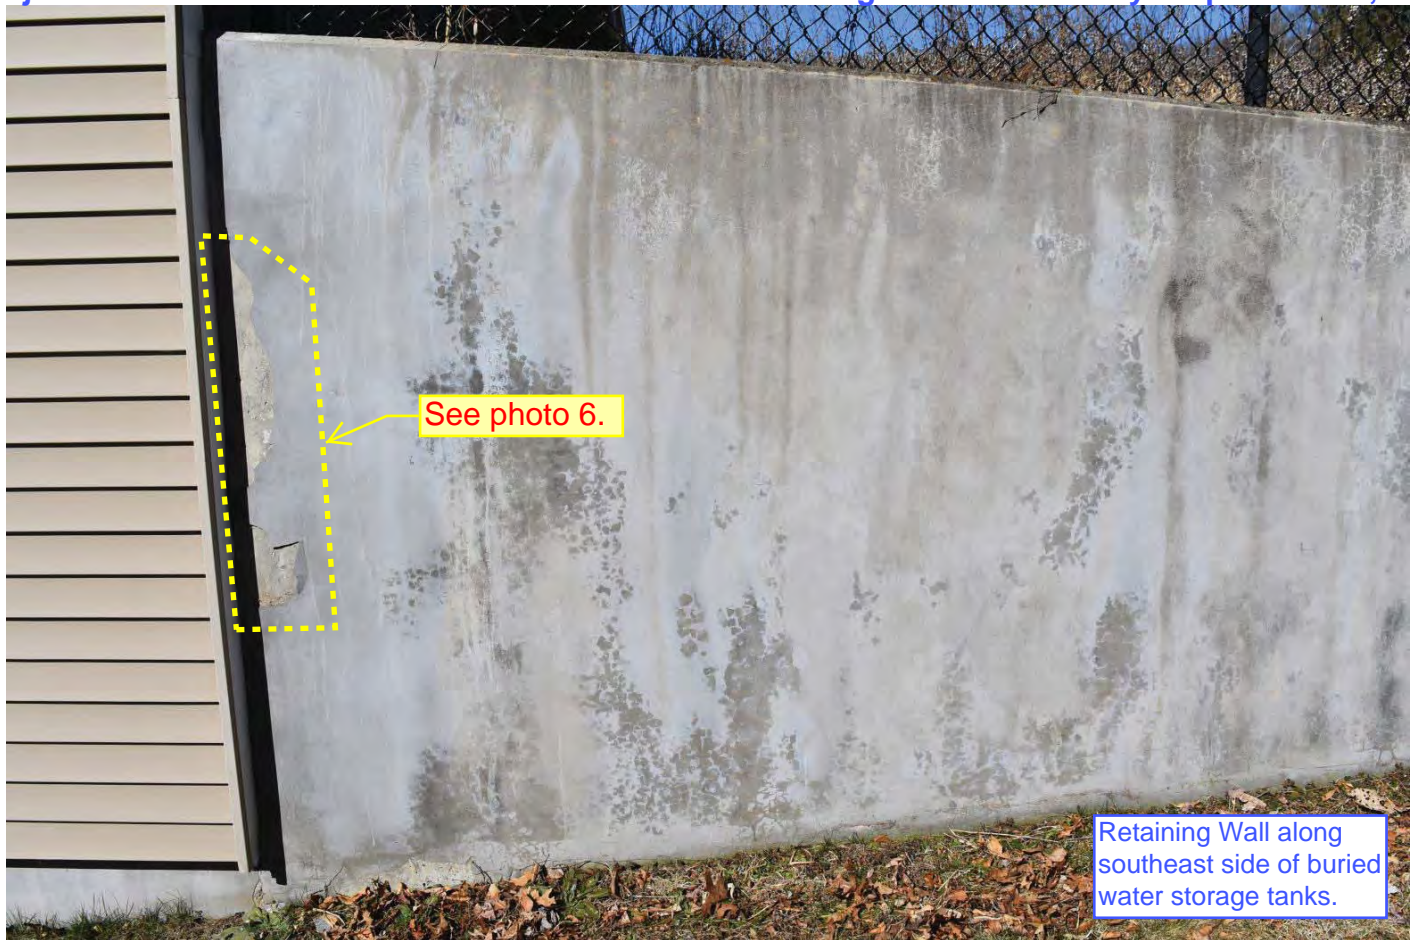
Photo 5

The retaining wall aligning with the southeast side of this structure currently exhibits poor adhesion of the parging to the underlying concrete wall. This degradation will continue as it experiences continued freeze-thaw cycles. Further, this water is exposed to moisture on both faces—the exposed face from rainwater, the earth-facing side from ground water that may penetrate the water-resisting coating. This wall is (or can be) independent of the building’s foundation. Should it exhibit continued deterioration over future years, and if its replacement becomes necessary, it should not have an impact on the functionality of this facility.

The only concrete showing signs of superficial deterioration is this retaining wall.

Partial end of building & retaining wall along southeast side of buried water storage tanks.

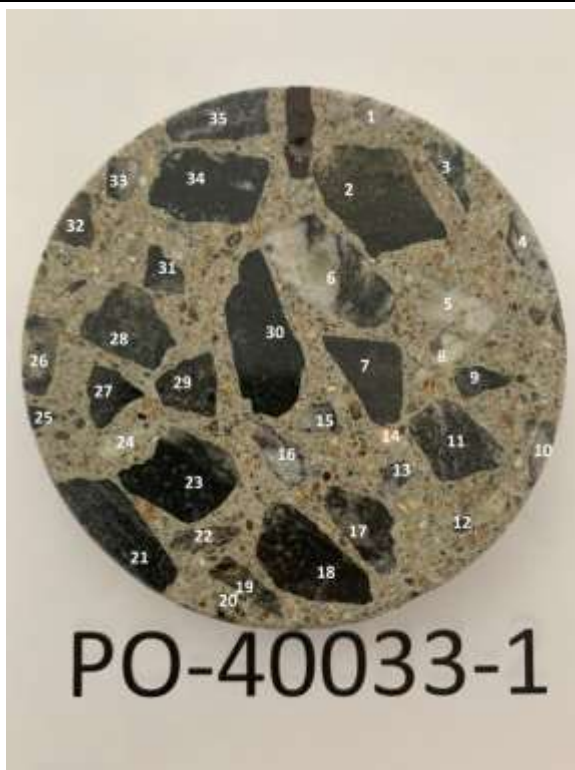
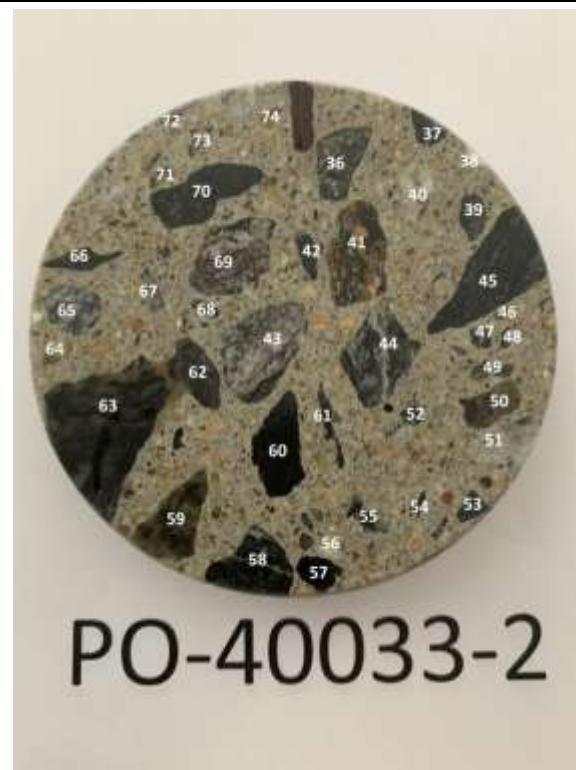
## Petrographic Examination on Polished Sections (ASTM C856)

<b>Total number of coarse aggregates :</b>	74 (two sections combined)
<b>Coarse aggregate composition (avg%) :</b>	Granitic gneiss (82), quartzite (7) and granite (11)
<b>% pyrrhotite-bearing aggregates :</b>	50% (37 of 74 particles)
<b>% higher potential reactivity aggregates:</b>	15% (11 of 74 particles)
<b>Iron Sulfide composition :</b>	Pyrrhotite (99%) Pyrite (0%), Chalcopyrite (1%)
<b>Sulfide oxidation :</b>	Low to moderate amounts of pyrrhotite oxidation and replacement iron oxides were observed in 24% of pyrrhotite-bearing coarse aggregates (9 of 37 particles), with no associated significant cracking distress.
